AUDI A5: CU4058

| Vinnumber: | WAUZZZ8TXDA079772 | Versionname: | A5 SB DPF Multitr.177PK Aut. |

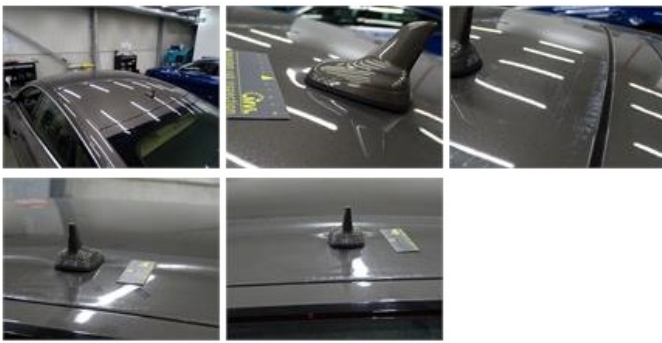
| Roof, Dent(s) and scratch(es), LI - Repair and paint (complete) | 577,80 |

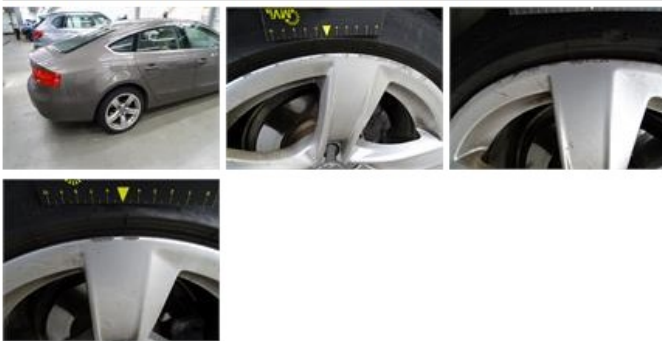
Alloy rim R R, Scratch(es), LI - Repair and paint (complete) 95,00

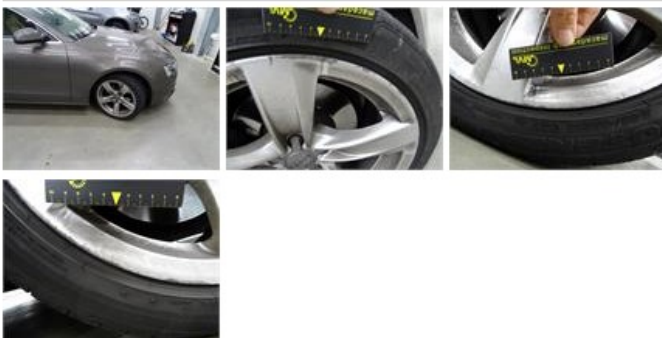
Alloy rim F R, Scratch(es), LI - Repair and paint (complete) 95,00

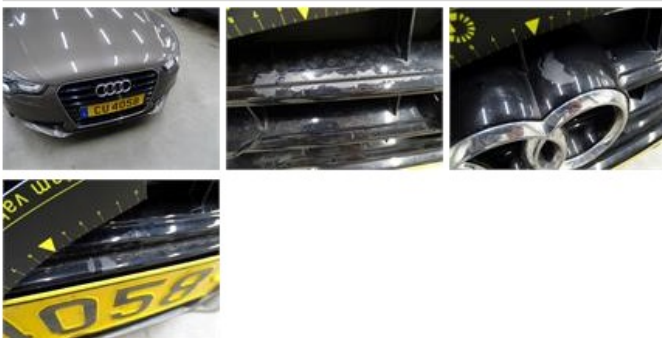
Grill frame, Scratch(es), Forfeit 125,00

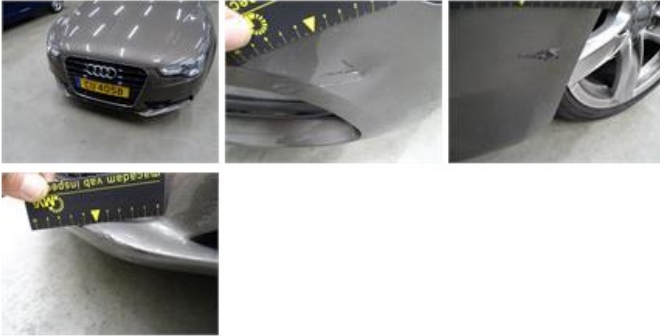
Bumper F, Dent(s) and scratch(es), LI - Repair and paint (complete)

254,16

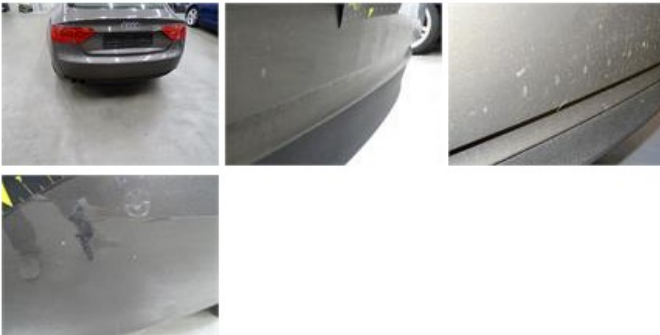
Bumper R, Dent(s) and scratch(es), LI - Repair and paint (complete)

254,16
