CITROEN DS5: 1FU0336

Limited Technical Inspection

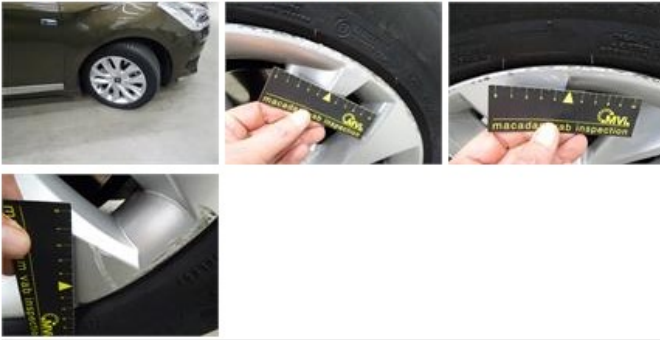
Alloy rim F R, Scratch(es), LI - Repair and paint (complete)

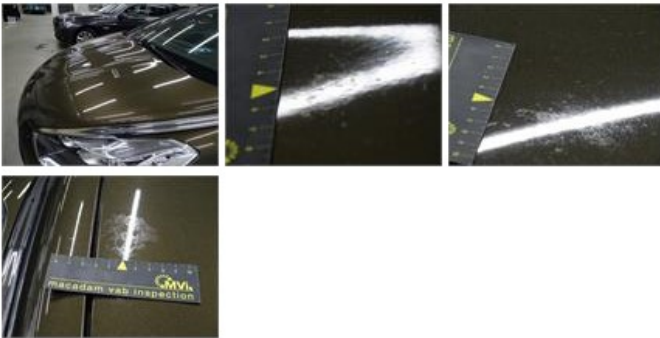
Bonnet, Chemical polution, LI - Repair and paint (complete)
