BMW 5: 1HJT265

Limited Technical Inspection

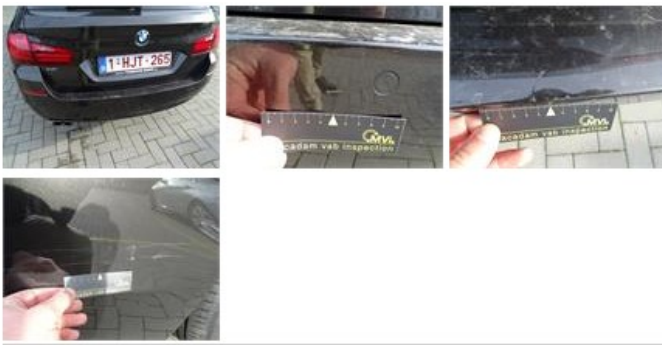
Bumper R, Scratch(es), LI - Repair and paint (complete)	254,16
---	---------------
