<b>BMW 5: 1FUJ167</b>			
Vinnumber:	<b>WBA5C11000D035225</b>	Versionname:	<b>5 BER 518d 136PK</b>
First Registrationdate:	<b>4/11/2013</b>	Fiscalpower:	
Expertise Mileage:	<b>170164</b>	Power Kw:	<b>100</b>
Bodytype:		Body color:	<b>Grey</b>
Gearbox:	<b>MAN 6 VIT</b>	Paint type:	<b>Metalic</b>
Transmission:	<b>Back</b>	Rims summer:	<b>Aluminium</b>
Fueltype:	<b>Diesel</b>	Oil level:	<b>OK</b>
Maintenance	<b>OK</b>		
Maintenance	<b>IN 15000 KM</b>		
Battery functioning	<b>Yes</b>		
Number of doors	<b>4</b>		
Number of seats	<b>5</b>		
Number head rests	<b>5</b>		
Rims summer	<b>Aluminium</b>		
Category	<b>Passenger Car</b>		
Oil level	<b>OK</b>		
Registration Certificate Car (BE)	<b>No</b>

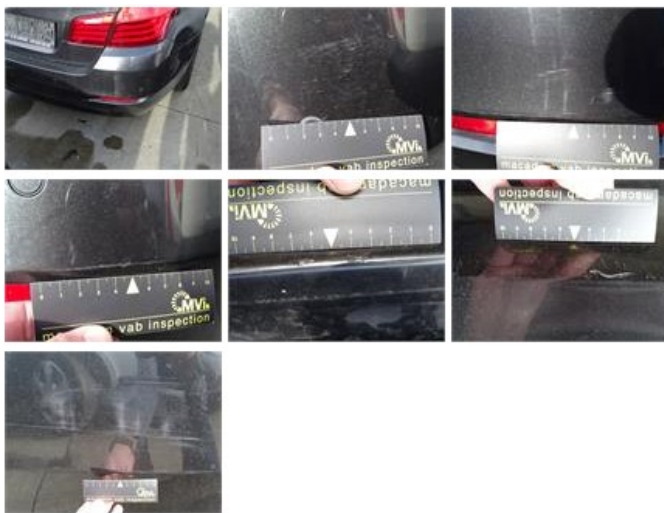
<b>Assistance equipment</b>			
Repair kit	<b>Yes</b>	Compressor	<b>Yes</b>
<b>Total cost ex VAT</b>			<b>1505,37</b>
<b>Bumper R, Dent(s) and scratch(es), LI - Repair and paint (complete)</b>			<b>254,16</b>

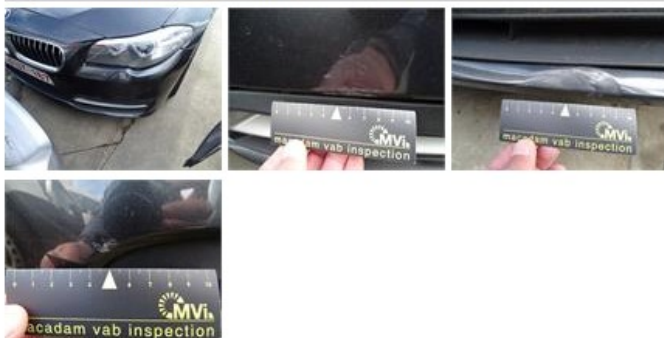
Bumper F, Dent(s) and scratch(es), LI - Repair and paint (complete)

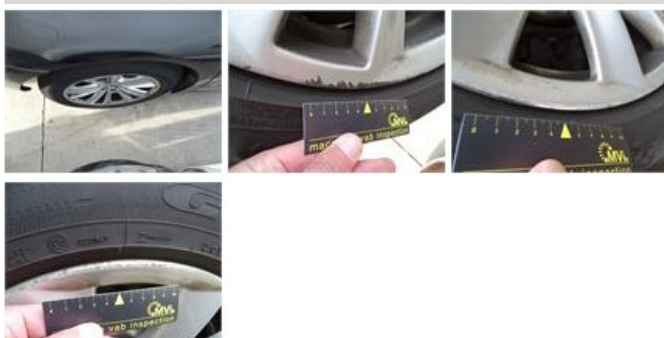
Alloy rim R R, Scratch(es), LI - Repair and paint (complete)

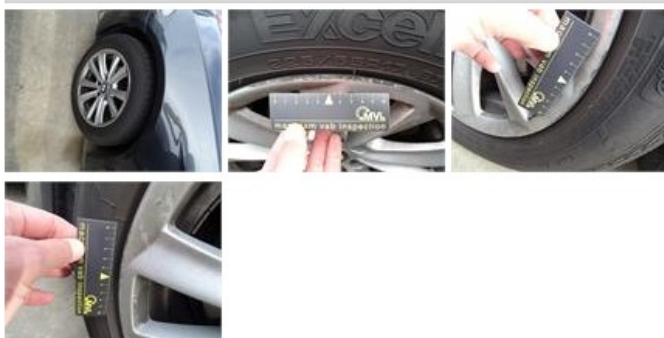
Alloy rim F L, Scratch(es), LI - Repair and paint (complete)

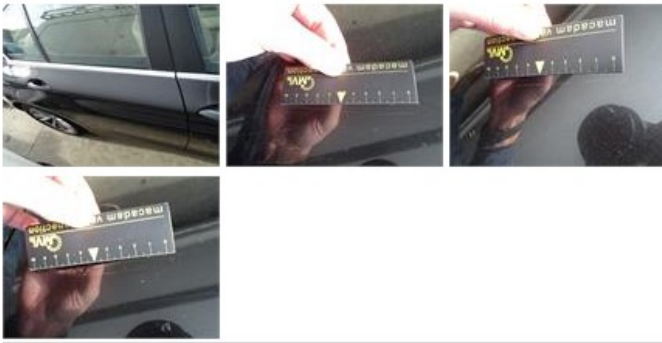
Door R R, Scratch(es), LI - Repair and paint (complete)

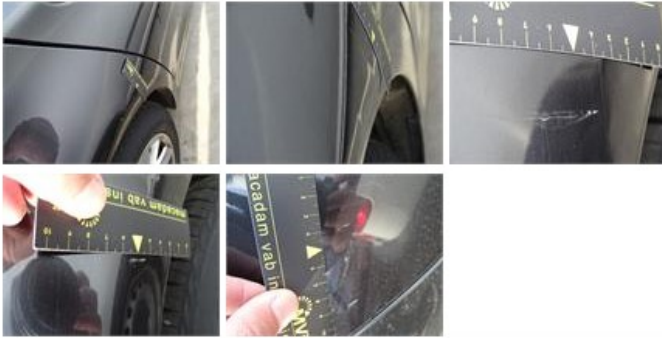
Wing R R, Dent(s) and scratch(es), LI - Repair and paint (complete) 369,84
