CITROËN C4 Picasso: 1GKX747

| Vinnumber: | VF73A9HC8EJ558491 | Versionname: | GR.C4 PICASSO Intensive 115PK |

Limited Technical Inspection

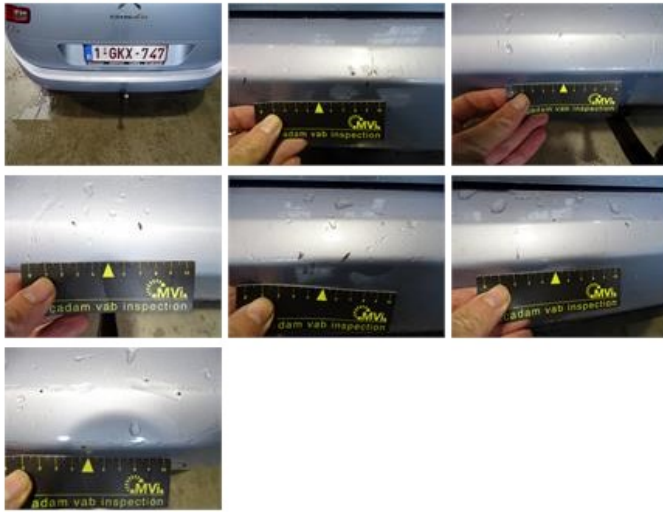
Bumper R, Scratch(es), LI - Repair and paint (complete)

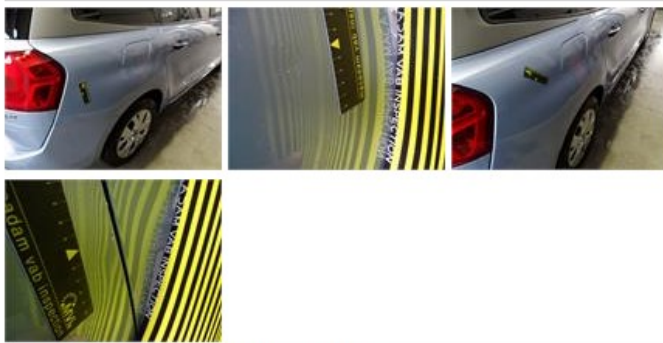
Wing R R, Dent(s), PDR - Paintless dent repair
