**OPEL Zafira: 1HDP251**

Vinnumber:	<b>WOLPD9E32E2078283</b>	Versionname:	<b>ZAFIRA TOURER ecoFLEX Business 136PK</b>
First Registrationdate:	<b>25/06/2014</b>	Fiscalpower:	
Expertise Mileage:	<b>86895</b>	Power Kw:	<b>100</b>
Bodytype:	<b>Hatchback</b>	Body color:	<b>Silver</b>
Gearbox:	<b>MAN 6 VIT</b>	Paint type:	<b>Metallic</b>
Transmission:	<b>Front</b>	Rims summer:	<b>Steel</b>
Fueltype:	<b>Diesel</b>	Oil level:	<b>OK</b>
Maintenance:	<b>NOT OK</b>	Parking lot:	<b>1424</b>
Battery functioning:	<b>Yes</b>		
Number of doors:	<b>5</b>		
Number of seats:	<b>5</b>		
Number head rests:	<b>5</b>		
Rims summer:	<b>Steel</b>		
Category:	<b>Passenger Car</b>		
Oil level:	<b>OK</b>		
Registration Certificate Car (BE):	<b>Yes</b>

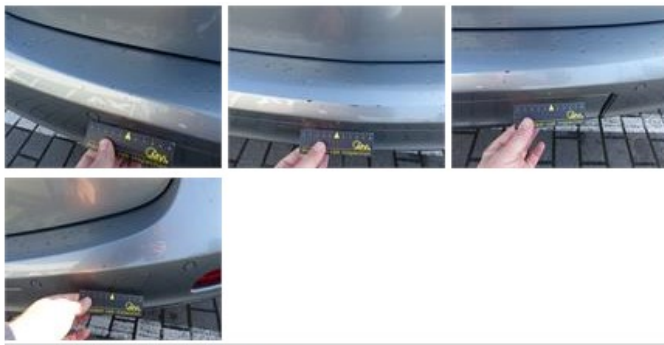
Total cost ex VAT	<b>1364,50</b>
Bumper R, Scratch(es), LI - Repair and paint (complete)	<b>211,80</b>

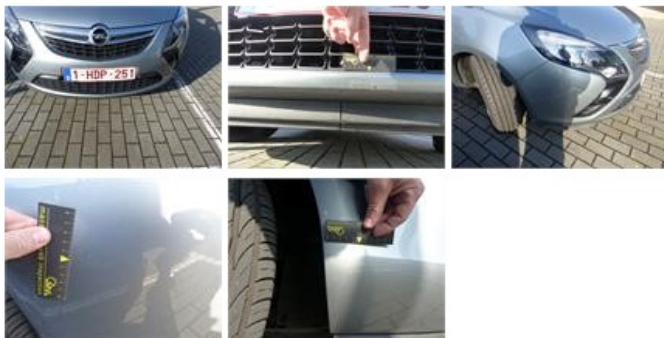
Door F L, Scratch(es), Acceptable	0,00
<i>No pictures to display</i>	
Bumper F, Scratch(es), LI - Repair and paint (complete)	211,80
