OPEL Insignia: 1GRB269

Limited Technical Inspection

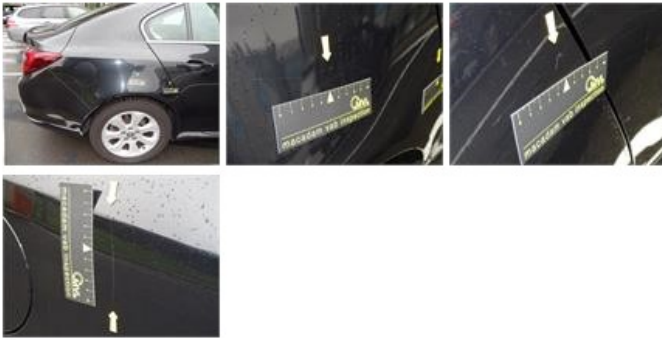
Wing R R, Scratch(es), 67 - Polish

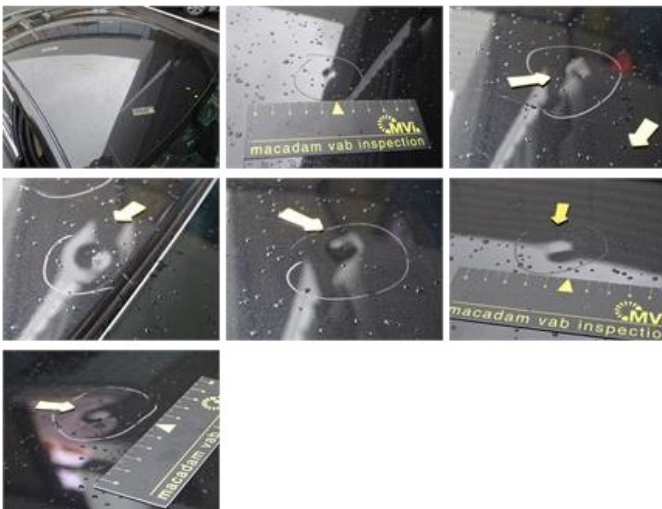
Roof, Hail damage, PDR - Hail

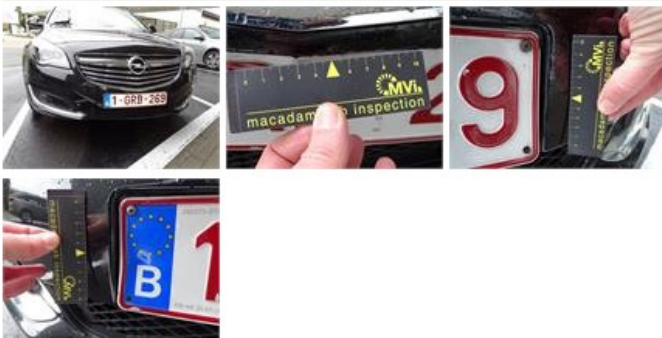
Bumper F, Dent(s) and scratch(es), LI - Repair and paint (complete)

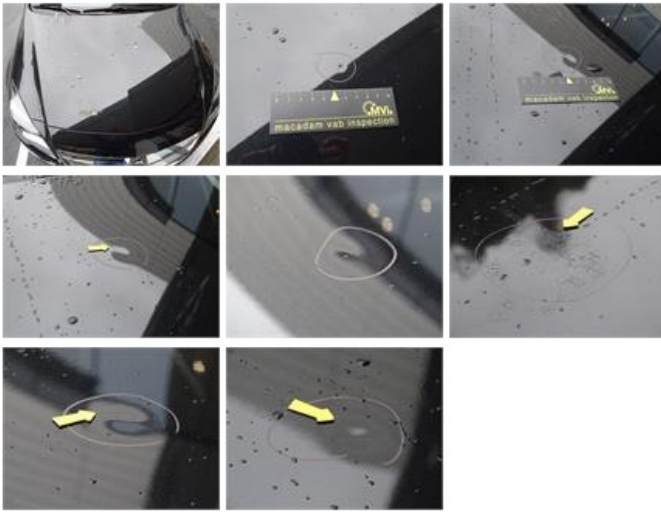
Bonnet, Hail damage, PDR - Hail

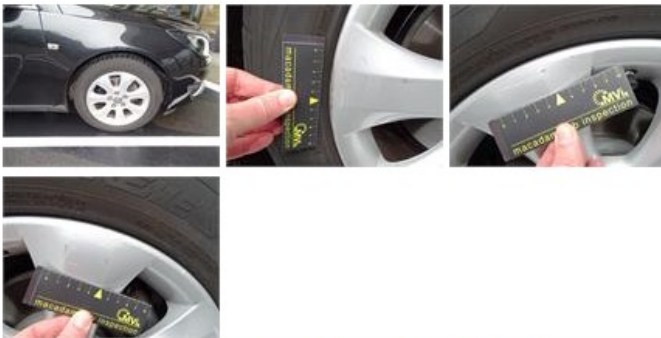
Alloy rim F R, Scratch(es), LI - Repair and paint (complete)

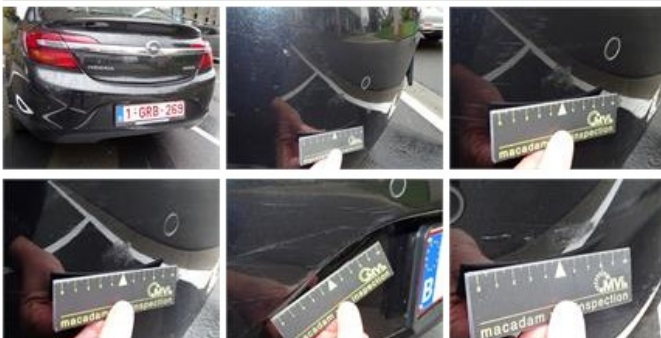
Bumper R, Dent(s) and scratch(es), LI - Repair and paint (complete)
