FORD Tourneo Custom: 1HUU489

Limited Technical Inspection

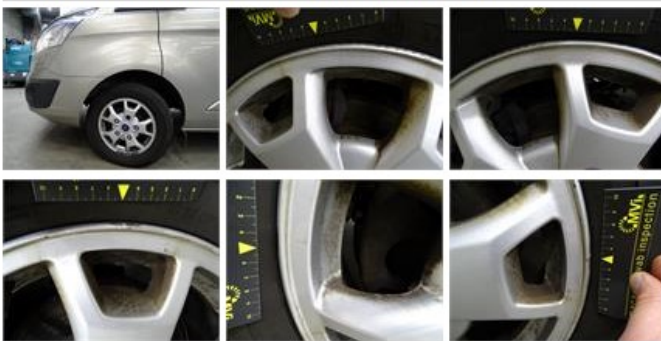
Alloy rim F L, Scratch(es), LI - Repair and paint (complete) 95,00

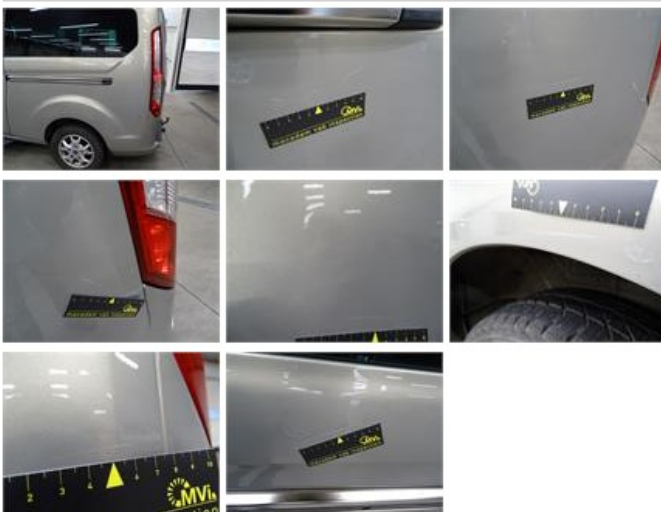
Wing R L, Scratch(es), LI - Repair and paint (complete) 231,15
