**PEUGEOT 308: 1HLL537**

**Limited Technical Inspection**

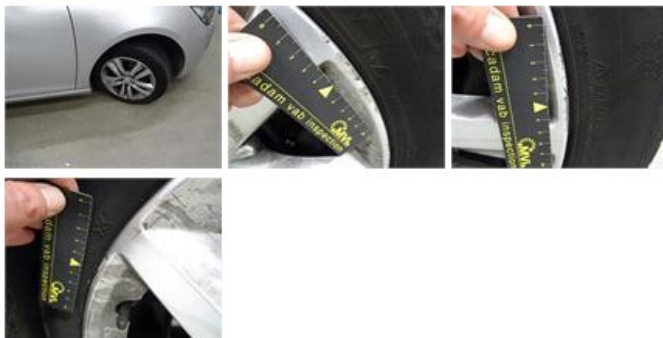
Alloy rim F R, Scratch(es), LI - Repair and paint (complete)

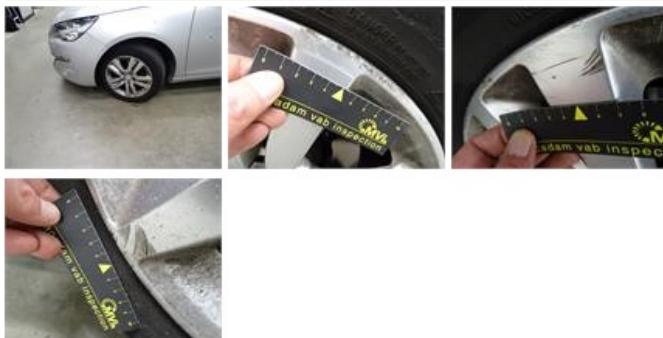
Alloy rim F L, Scratch(es), LI - Repair and paint (complete)
