BMW 1 HATCH: GZ4359

Limited Technical Inspection

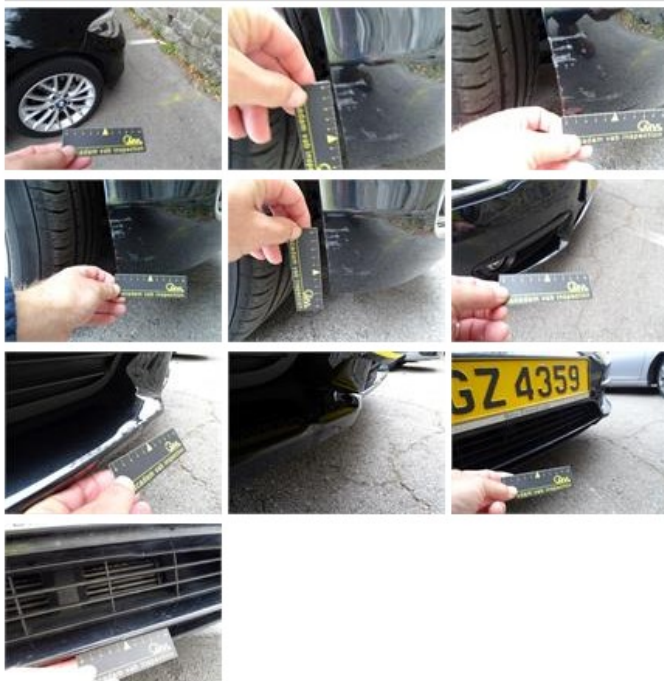
Bumper R, Dent(s) and scratch(es), Acceptable 0,00

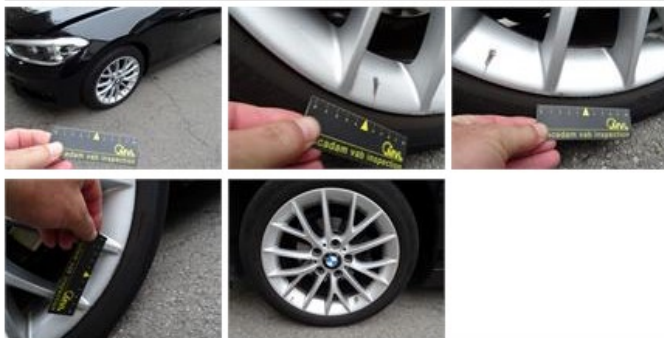
Alloy rim F L, Scratch(es), LI - Repair and paint (complete) 95,00

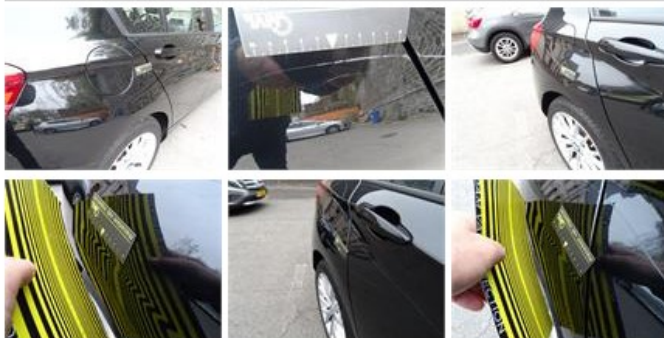
Wing R R, Dent(s) and scratch(es), LI - Repair and paint (complete) 428,20
