AUDI A1 SPORTBACK: 1PYC156

| Vinnumber: | WAUZZZ8X2HB032142 | Versionname: | 1.4 TDI 66kW |

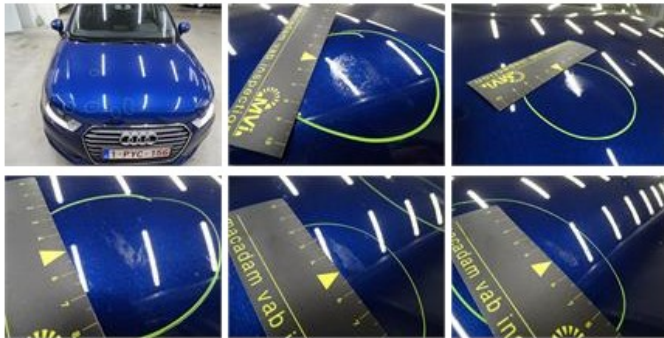
Bonnet, Chemical polution, LI - Repair and paint (complete) 232,06

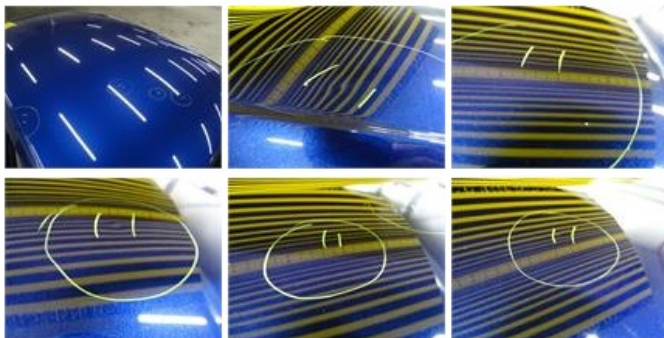
Roof, Hail damage, PDR - Hail 125,00

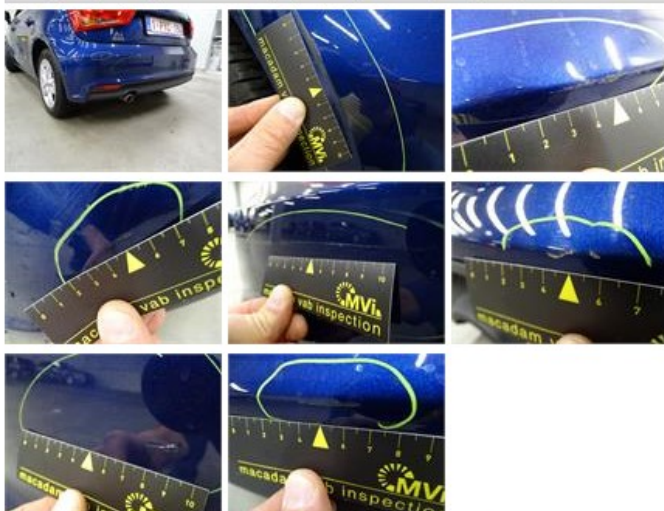
Bumper R, Dent(s) and scratch(es), LI - Repair and paint (complete) 169,44
