BMW 3 TOURING: 1JKD326

Limited Technical Inspection

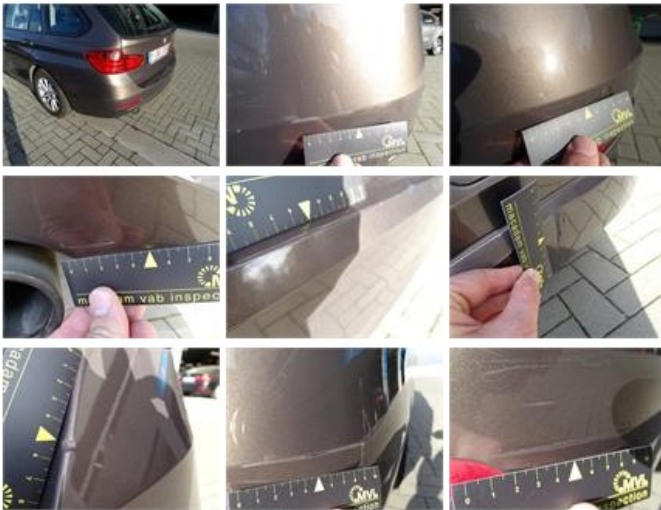
Bumper R, Dent(s) and scratch(es), LI - Repair and paint (complete) 307,80
