BMW 3: 1GRT195

| Vinnumber: | WBA3K91040F934358 | Versionname: | 3 TOURING 316d 116PK |

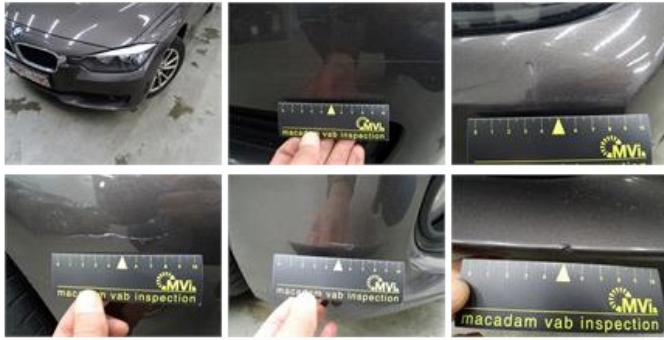
Bumper F, Scratch(es), LI - Repair and paint (complete) 211,80

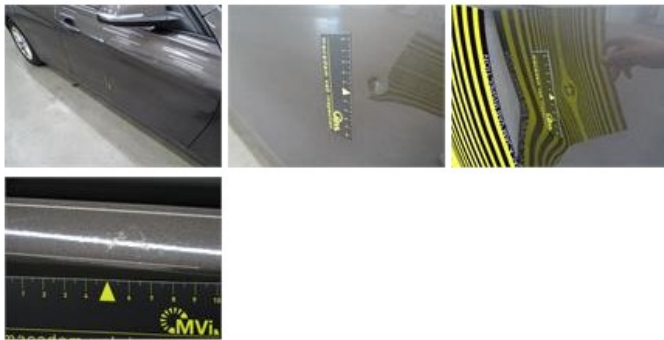
Door F R, Dent(s) and scratch(es), LI - Repair and paint (complete) 318,35

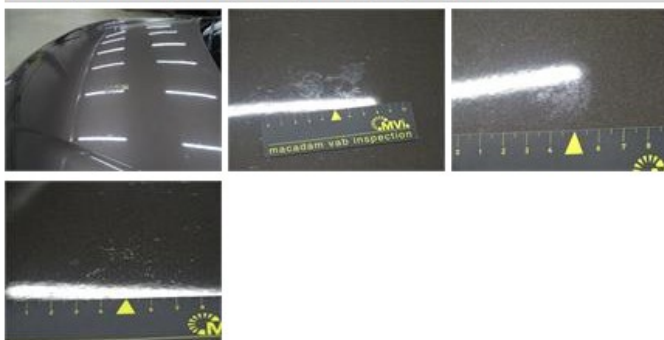
Bonnet, Chemical polution, LI - Repair and paint (complete) 290,08

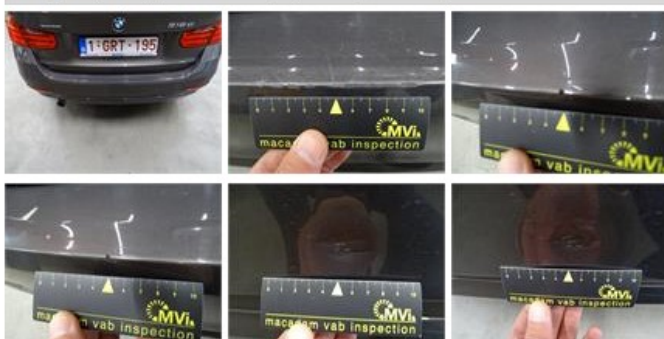
Bumper R, Dent(s) and scratch(es), Le - Replace and paint 651,00
