BMW 1 HATCH: GZ4388

Limited Technical Inspection

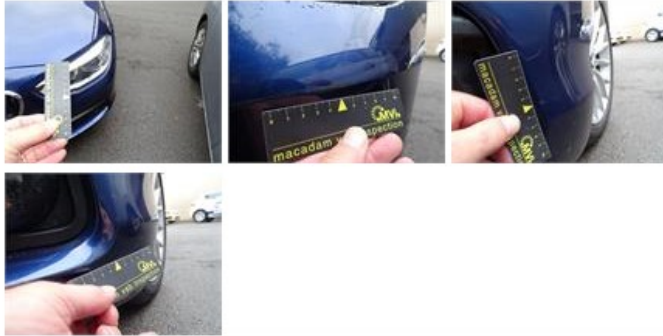
<i>No pictures to display</i>	
LED headlight L, Scratch(es), Acceptable	0,00
<i>No pictures to display</i>	
Spare wheel, Missing, Acceptable	0,00
<i>No pictures to display</i>	
Certificate Of Conformity, Missing, E - Replace	0,00
<i>No pictures to display</i>	
Door F R, Not original part, Acceptable	0,00
<i>No pictures to display</i>	
Wing R L, Scratch(es), Acceptable	0,00
<i>No pictures to display</i>	
Interior, Dirty, Acceptable	0,00
<i>No pictures to display</i>	
Door R R, Not original part, Acceptable	0,00
<i>No pictures to display</i>	
Alloy rim F R, Scratch(es), Acceptable	0,00
<i>No pictures to display</i>	
Bumper F, Scratch(es), It - Spot repair	115,56
