BMW 1 HATCH: GZ4362

| Vinnnumber: | WBA1V91060V739477 | Versionname: | 1.5 116D EFFICIENTDYNAMICS EDIT. (85KW) |

Limited Technical Inspection

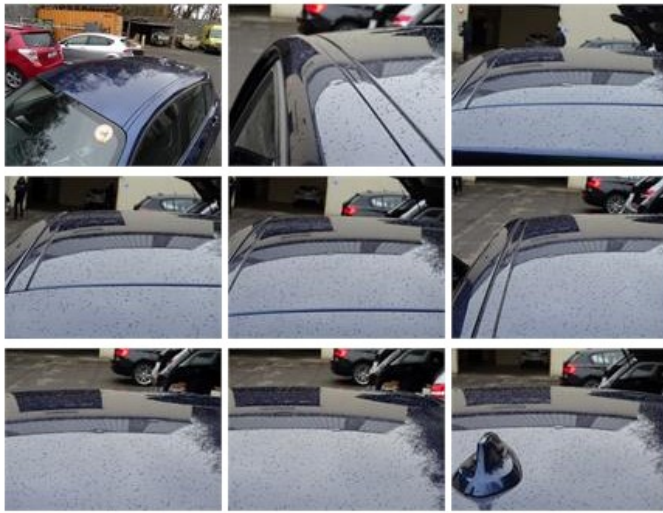
| Roof, Hail damage, PDR - Hail | | 1250,00 |
