MERCEDES A: 1JGF695

Limited Technical Inspection

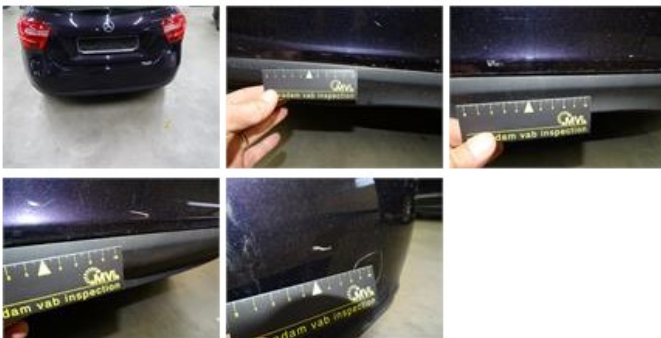
Bumper R, Scratch(es), LI - Repair and paint (complete) 211,80
