VOLKSWAGEN Golf: 1HYP524

Limited Technical Inspection

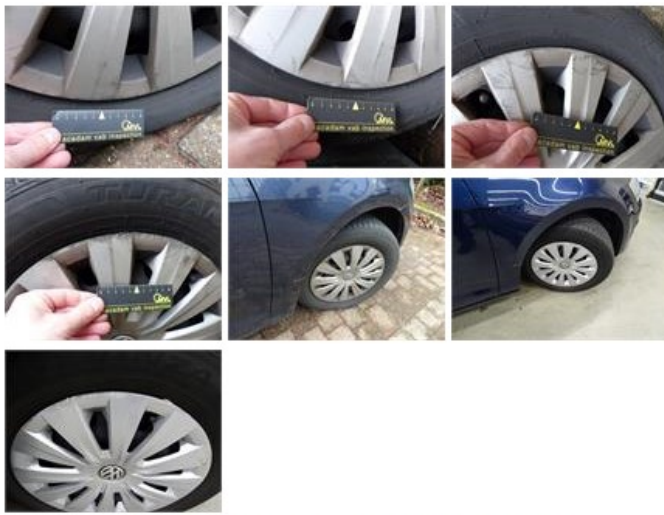
Wheel cover F R, Scratch(es), E - Replace	30,00
---	--------------

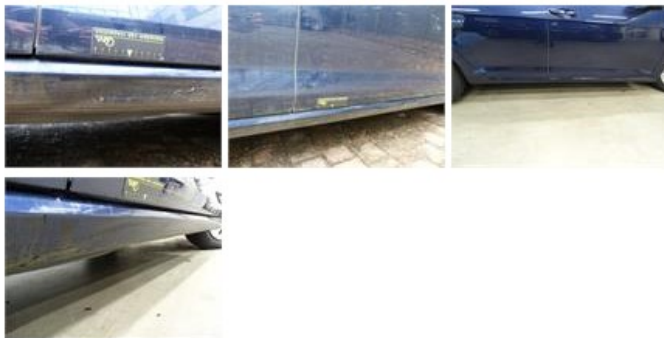
Sill outer R, Dent(s) and scratch(es), LI - Repair and paint (complete) 310,50

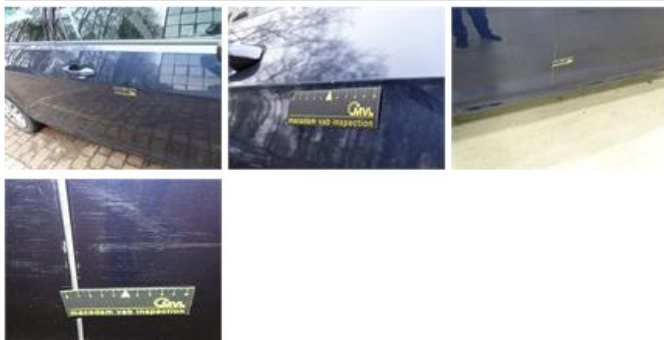
Door F R, Dent(s) and scratch(es), Acceptable 0,00

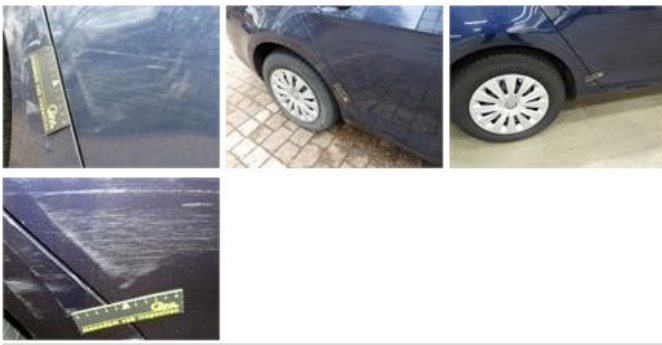
Door R R, Dent(s) and scratch(es), LI - Repair and paint (complete) 318,35

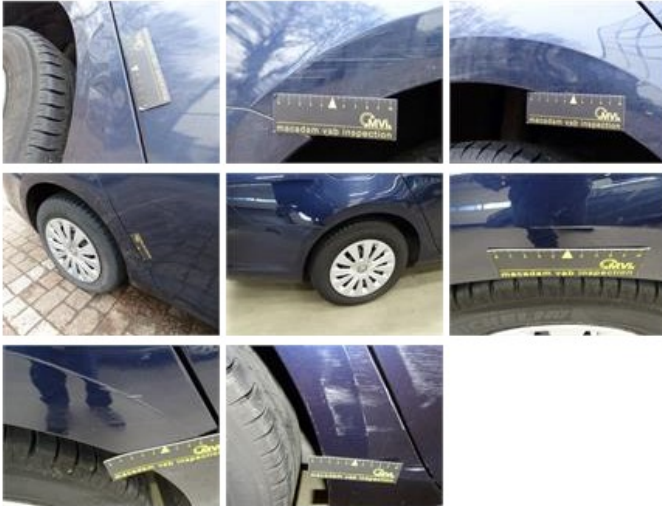
Wing R R, Dent(s) and scratch(es), LI - Repair and paint (complete) 308,20

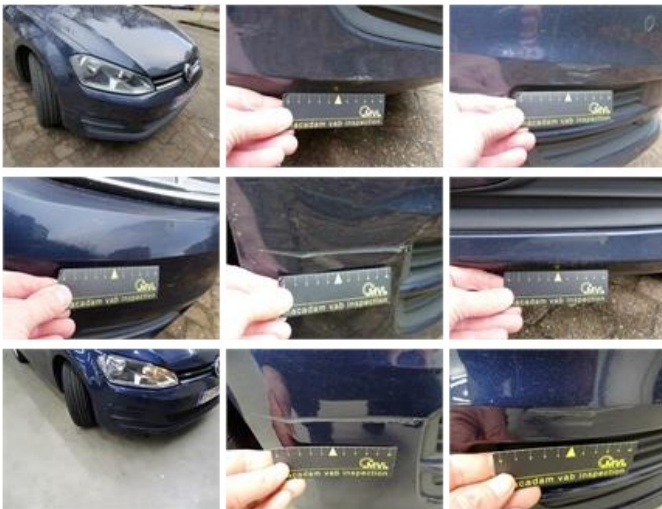
Bumper F, Scratch(es), LI - Repair and paint (complete) 211,80

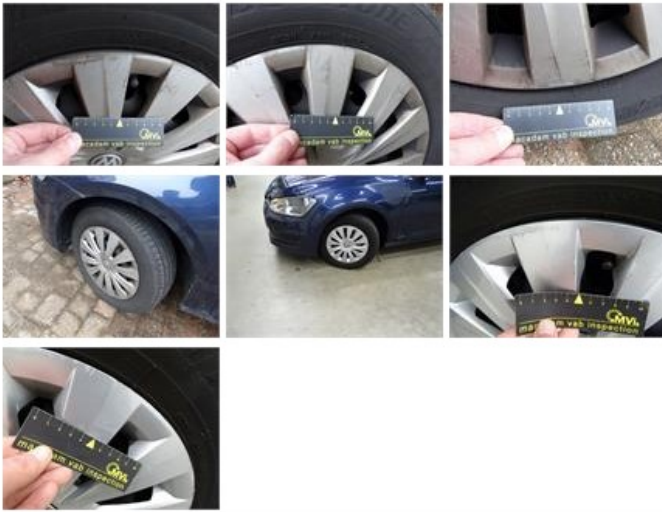
Wheel cover F L, Scratch(es), E - Replace

30,00

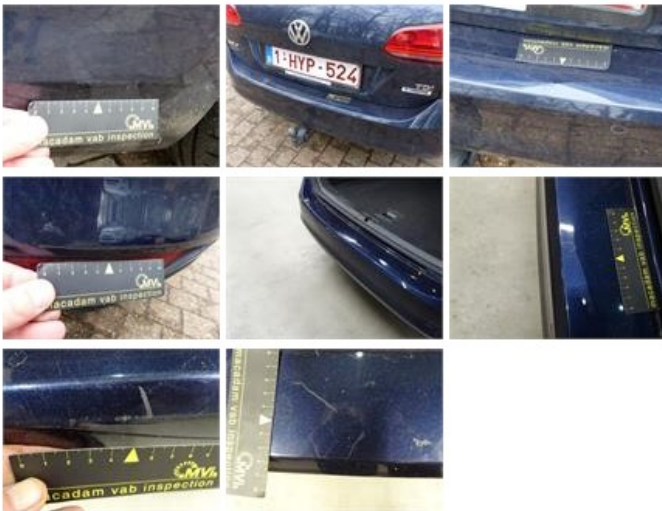
Bumper R, Dent(s) and scratch(es), LI - Repair and paint (complete)

211,80

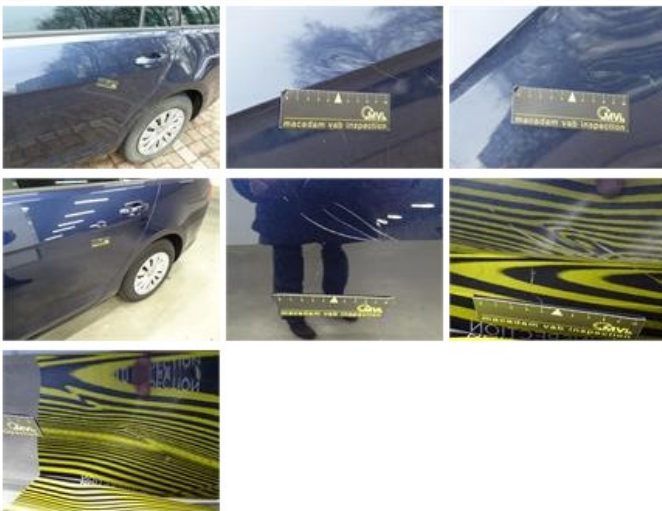
Door R L, Dent(s) and scratch(es), LI - Repair and paint (complete)

318,35
