SKODA Superb: 1HFG296

Limited Technical Inspection

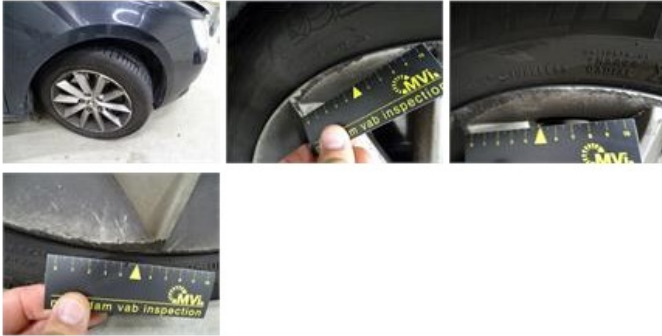
Alloy rim F R, Scratch(es), LI - Repair and paint (complete)	95,00
--	-------
