TOYOTA AURIS: YX7352

Limited Technical Inspection

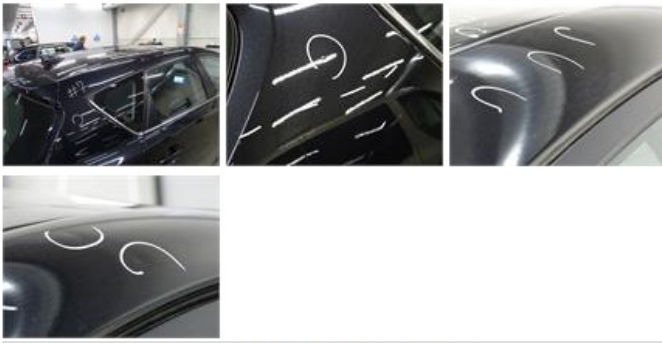
Roof pillar R, Hail damage, PDR - Hail	175,00
--	--------

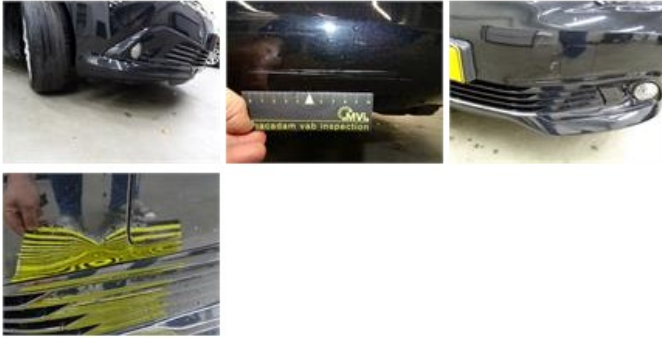
Bumper F, Scratch(es), LI - Repair and paint (complete) 211,80

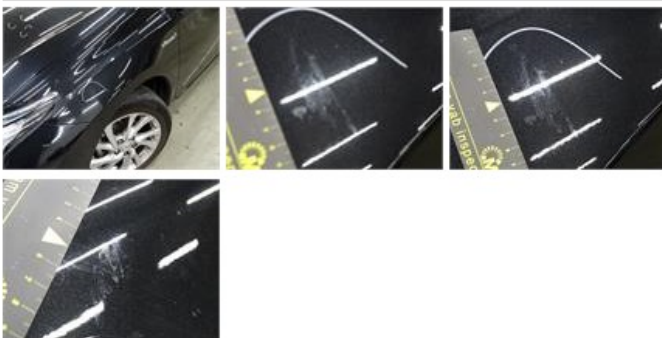
Wing F L, Chemical pollution, LI - Repair and paint (complete) 220,18

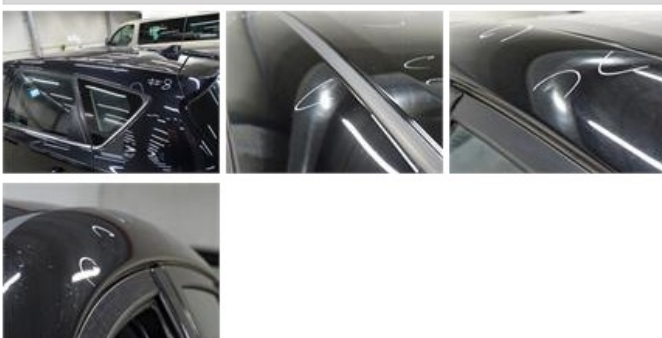
Roof pillar L, Hail damage, PDR - Hail 200,00

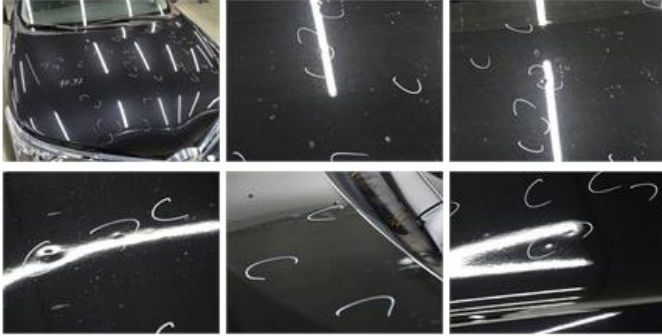
Bonnet, Hail damage, LI - Repair and paint (complete) 530,08

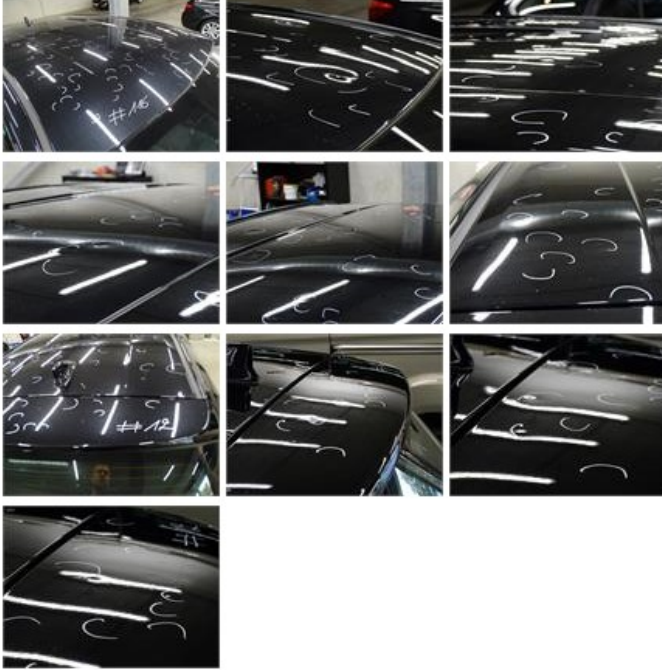
Roof, Hail damage, LI - Repair and paint (complete) 865,50
