VOLKSWAGEN Golf: 1HYZ920

Limited Technical Inspection

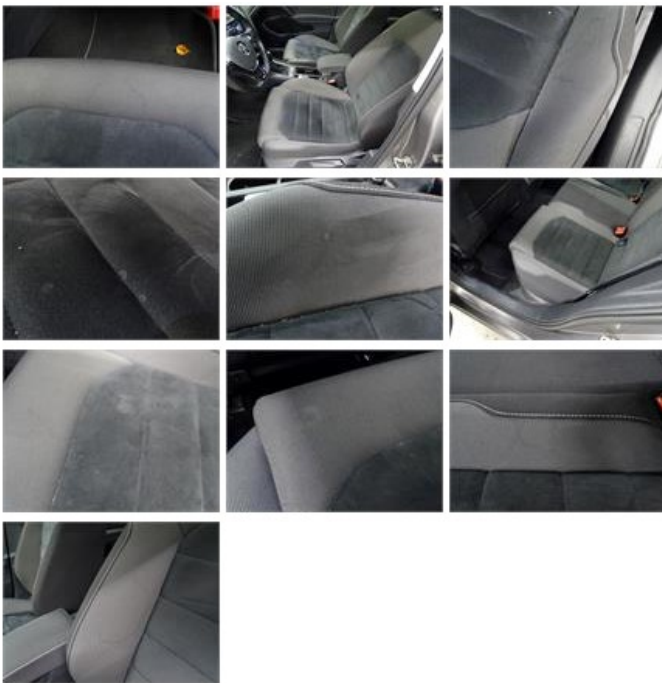
Interior, Dirty, Cleaning

125,00

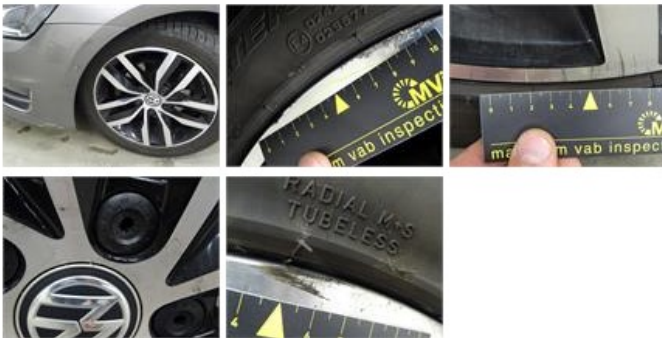
Alloy rim F L polished, Scratch(es), LI - Repair and paint (complete) 95,00

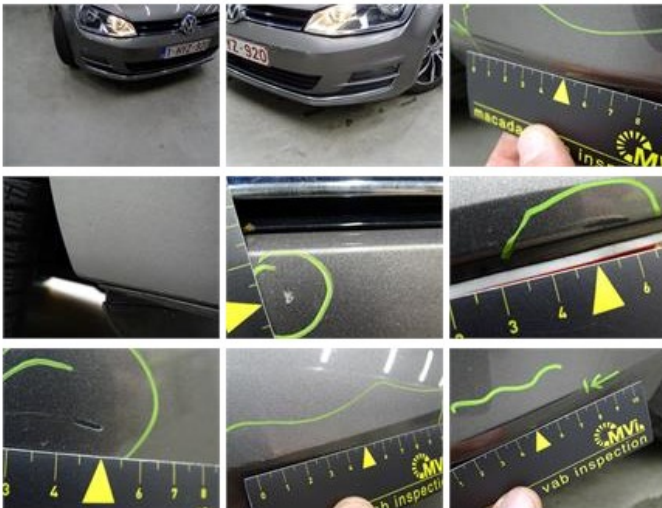
Bumper F, Scratch(es), LI - Repair and paint (complete) 211,80
