VOLVO XC60: 1GEG077

Limited Technical Inspection

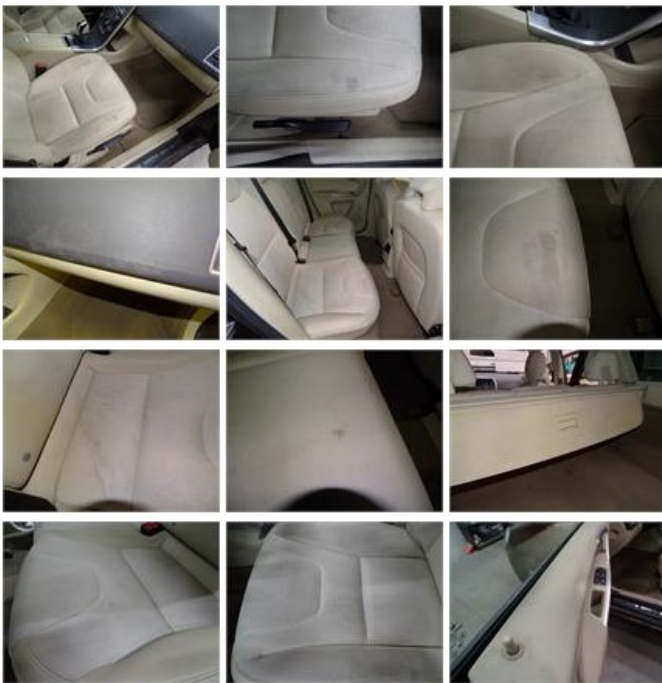
Total cost ex VAT	1400,27
Alloy rim F R, Scratch(es), LI - Repair and paint (complete)	95,00
<i>No pictures to display</i>	
Interior, Dirty, Cleaning	125,00

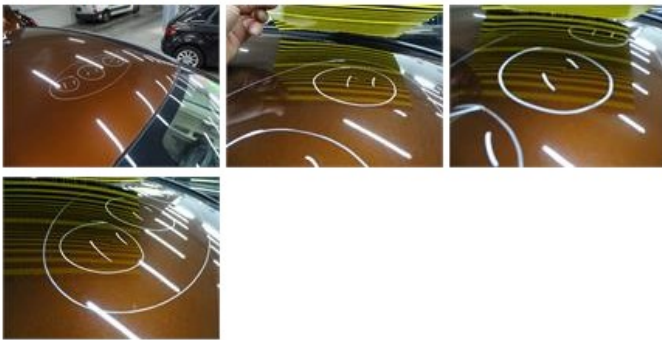
Roof, Dent(s), PDR - Paintless dent repair 102,60
