**VOLKSWAGEN Golf: 1GCS597**

**Limited Technical Inspection**

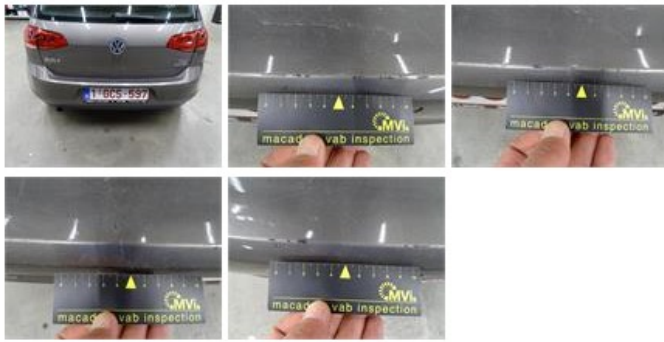
Bumper R, Scratch(es), LI - Repair and paint (complete) 211,80

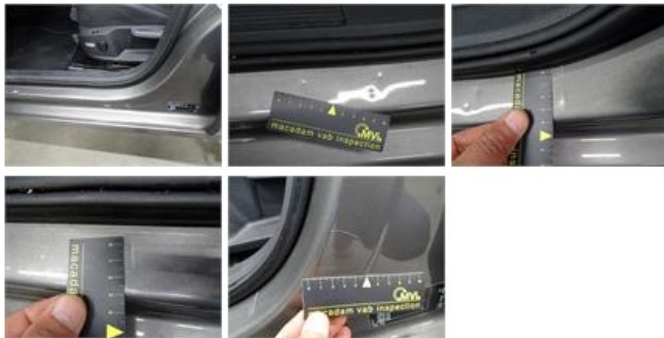
Door frame F L, Scratch(es), It - Spot repair 115,56
