PEUGEOT 308 SW: 1KPP071

Limited Technical Inspection

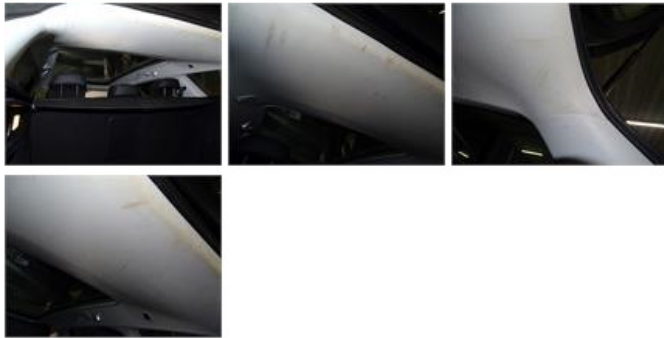
Ceiling, Stain, Cleaning

25,00
