BMW 3: 1HFL190

| Vinnumber: | WBA3K91030F935257 | Versionname: | 3 TOURING 316d 116PK |

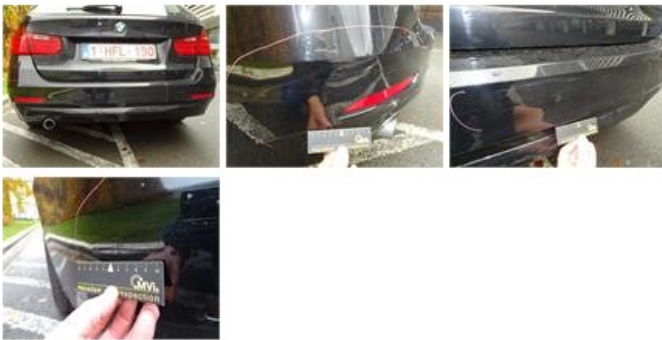
Bumper R, Dent(s) and scratch(es), LI - Repair and paint (complete)

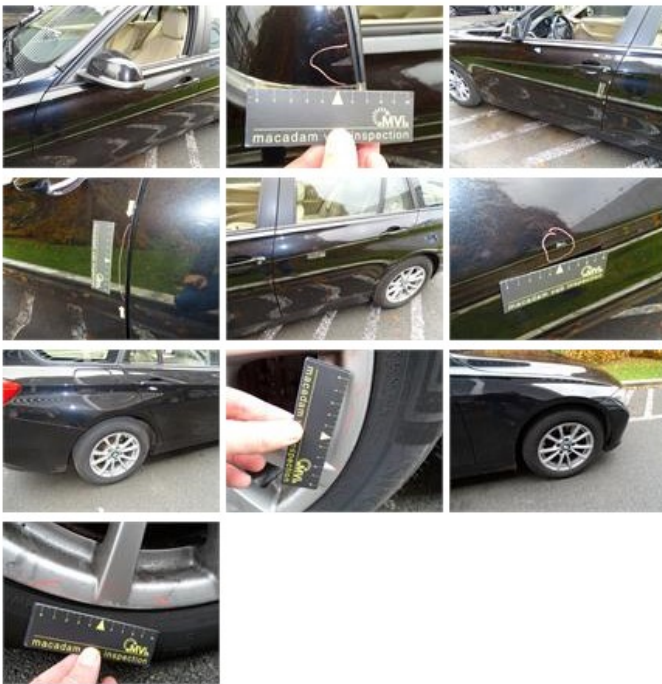
Bodywork, Damaged, Acceptable

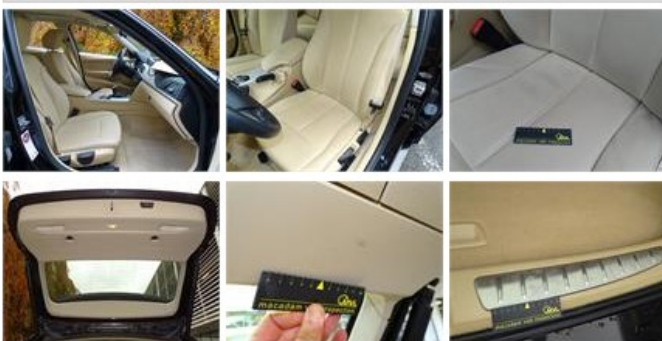
Interior, Damaged, Acceptable

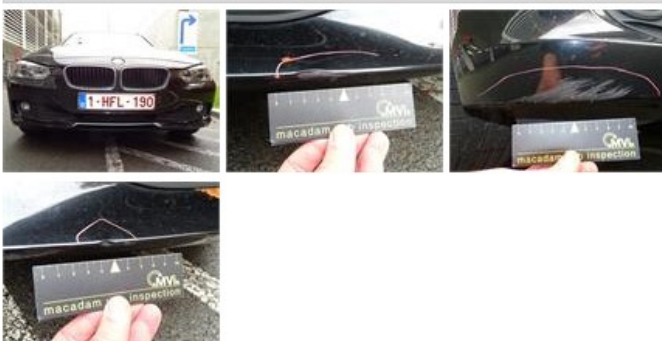
Bumper F, Dent(s) and scratch(es), LI - Repair and paint (complete)
