BMW 3: 1GFH161

Limited Technical Inspection

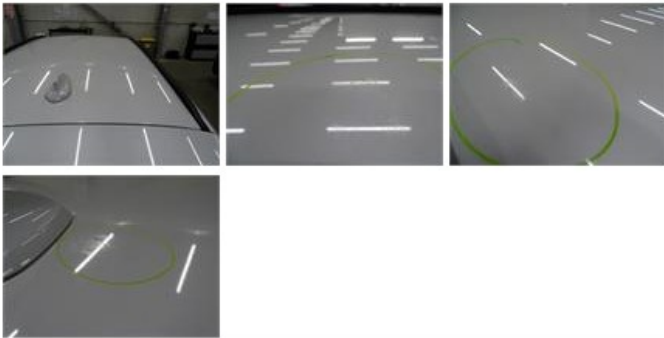
<i>No pictures to display</i>		
Windscreen, Stone chip(s), Acceptable		0,00
<i>No pictures to display</i>		
Wing R R, Dent(s) and scratch(es), LI - Repair and paint (complete)		308,20
<i>No pictures to display</i>		
Interior, Dirty, Cleaning		0,00
<i>No pictures to display</i>		
Alloy rim R L, Scratch(es), Acceptable		0,00
<i>No pictures to display</i>		
Bonnet, Scratch(es), Acceptable		0,00
<i>No pictures to display</i>		
Door R L, Scratch(es), Acceptable		0,00
<i>No pictures to display</i>		
Door F L, Scratch(es), Acceptable		0,00
<i>No pictures to display</i>		
Wing R L, Scratch(es), Acceptable		0,00
<i>No pictures to display</i>		
Bumper F, Scratch(es), Acceptable		0,00
<i>No pictures to display</i>		
Roof, Chemical pollution, LI - Repair and paint (complete)		481,50

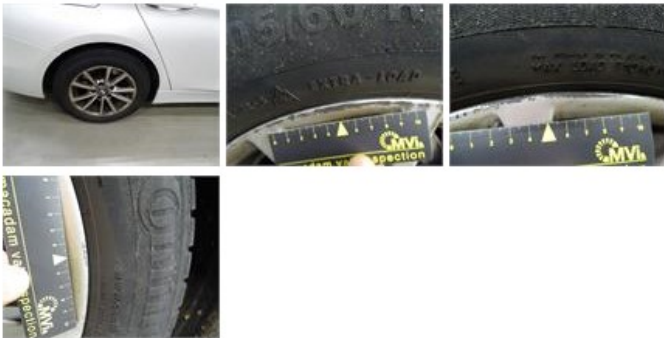
Alloy rim R R, Scratch(es), LI - Repair and paint (complete)		95,00
--	--	-------
