MERCEDES A: 1GSI484

Limited Technical Inspection

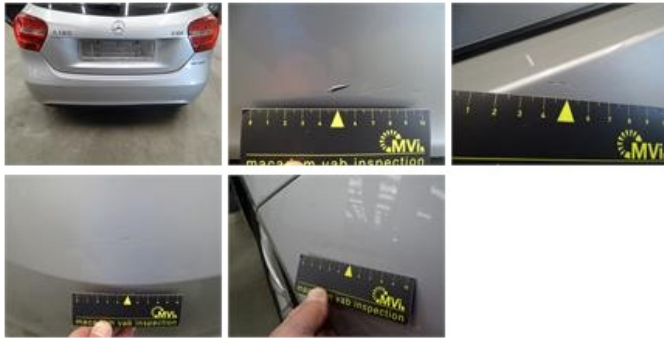
Bumper R, Scratch(es), LI - Repair and paint (complete)

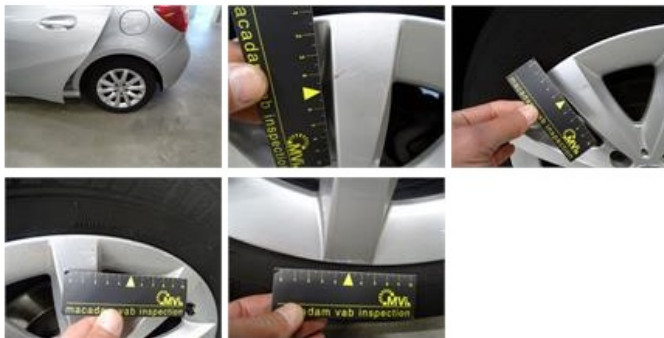
Alloy rim R L, Scratch(es), I - Repair

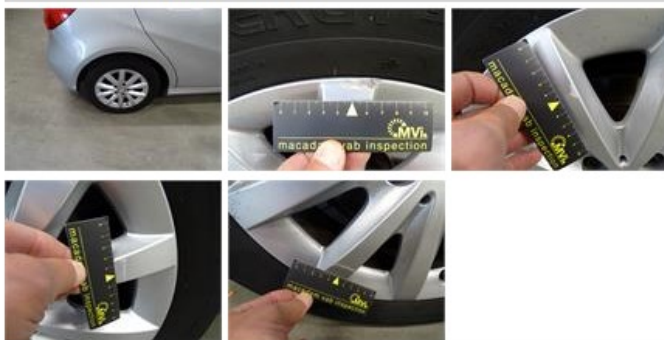
Alloy rim R R, Scratch(es), I - Repair
