**VOLVO V70: 1ERW854**

**Limited Technical Inspection**

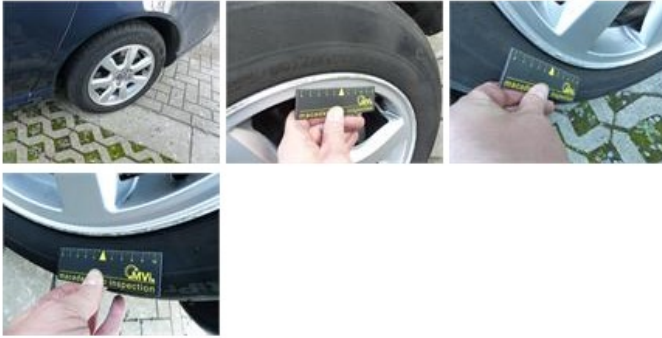
Alloy rim R L, Scratch(es), LI - Repair and paint (complete) 95,00

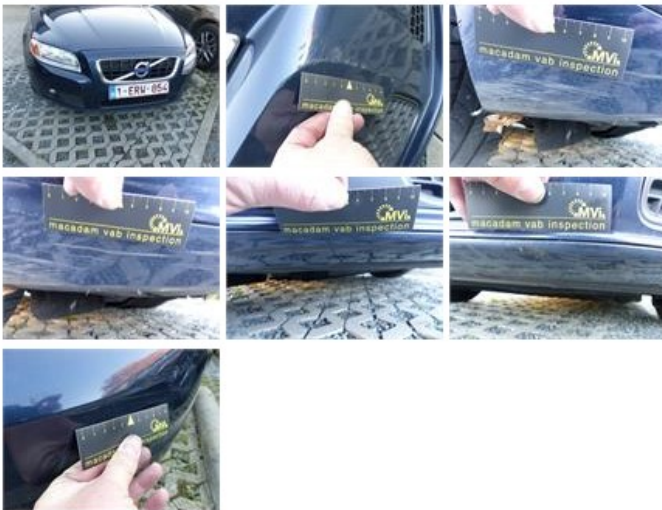
Bumper F, Scratch(es), LI - Repair and paint (complete) 254,16

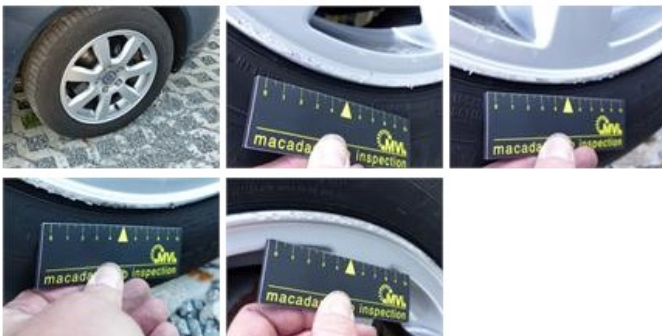
Alloy rim F R, Scratch(es), LI - Repair and paint (complete) 95,00

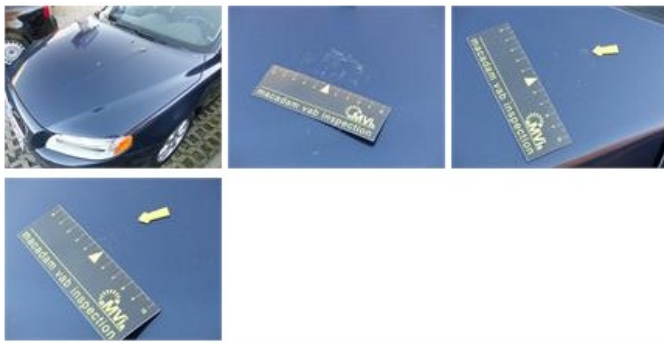
Bonnet, Chemical polution, LI - Repair and paint (complete) 348,09

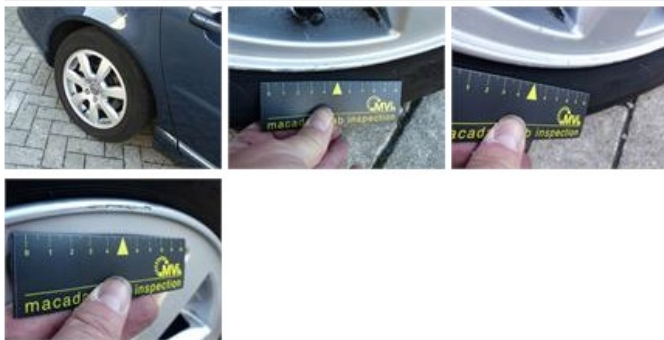
Alloy rim R R, Scratch(es), LI - Repair and paint (complete) 95,00

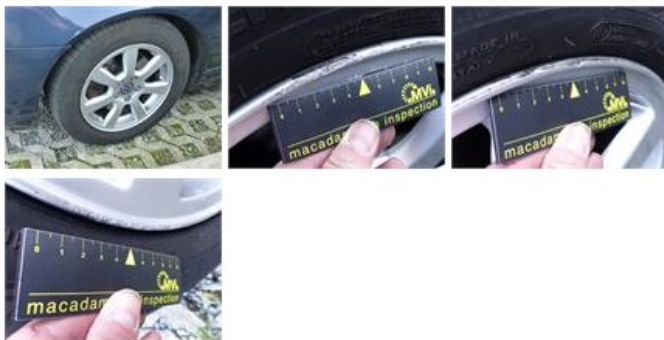
Alloy rim F L, Scratch(es), LI - Repair and paint (complete) 95,00
