**AUDI A3: 1GWJ327**

**Limited Technical Inspection**

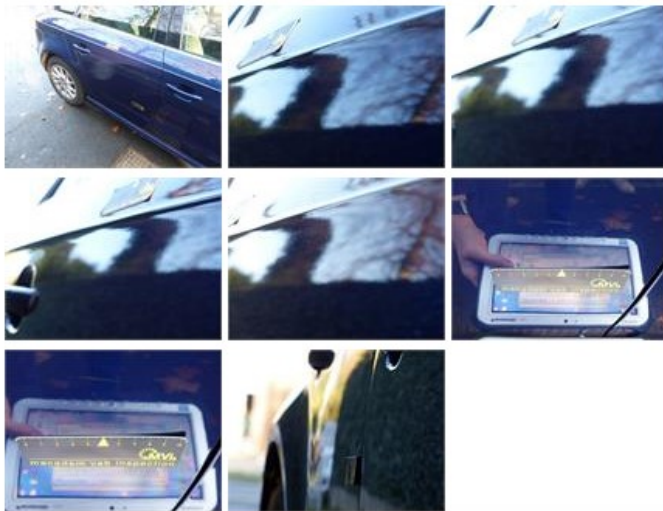
Bodywork, Not original part, Acceptable	0,00
<i>No pictures to display</i>	
Roof, Dent(s), Acceptable	0,00
<i>No pictures to display</i>	
Rear bulkhead lining, Scratch(es), Acceptable	0,00
<i>No pictures to display</i>	
Windscreen, Stone chip(s), Acceptable	0,00
<i>No pictures to display</i>	
Sill trim R L, Scratch(es), Acceptable	0,00
<i>No pictures to display</i>	
Sill outer R, Scratch(es), Acceptable	0,00
<i>No pictures to display</i>	
Internal Boot Lining L, Scratch(es), Acceptable	0,00
<i>No pictures to display</i>	
Door F R, Repaired, Acceptable	0,00
<i>No pictures to display</i>	
Outer backrest protection L, Scratch(es), Acceptable	0,00
<i>No pictures to display</i>	
Sill trim R R, Scratch(es), Acceptable	0,00
<i>No pictures to display</i>	
Wing F L, Scratch(es), Acceptable	0,00
<i>No pictures to display</i>	
Wing R R, Repaired, Acceptable	0,00
<i>No pictures to display</i>	
Door R R, Bad repair, Acceptable	0,00

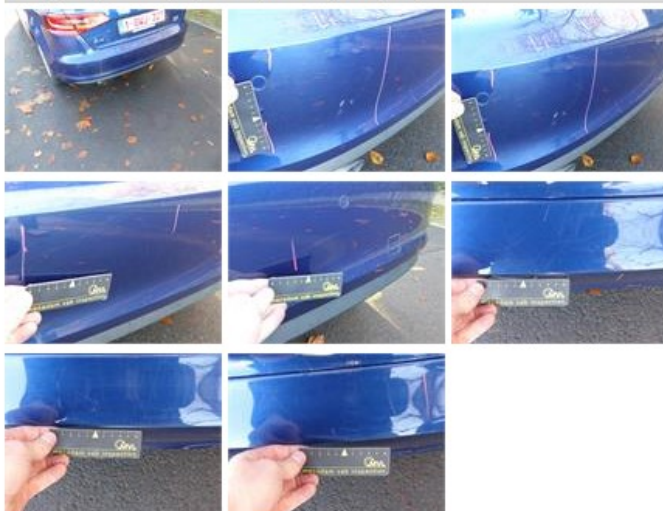
Bumper F, Scratch(es), Acceptable	0,00
<i>No pictures to display</i>	
Door R L, Scratch(es), Acceptable	0,00
<i>No pictures to display</i>	
Door F L, Scratch(es), Acceptable	0,00
<i>No pictures to display</i>	
Trunk lid covering R, Scratch(es), Acceptable	0,00
<i>No pictures to display</i>	
Wing F L, Repaired, Acceptable	0,00
<i>No pictures to display</i>	
Bumper R, Scratch(es), LI - Repair and paint (complete)	235,80

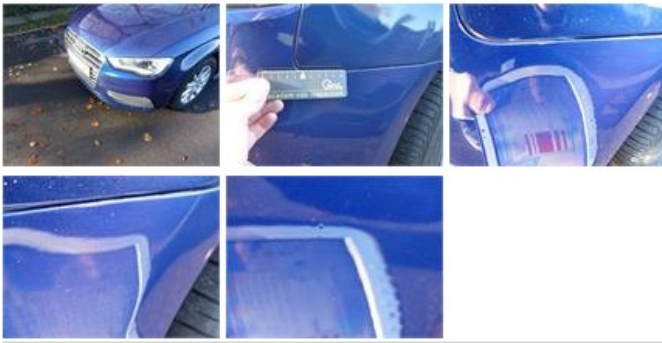
Bumper F, Bad repair, Acceptable	0,00
----------------------------------	------
