**AUDI A1 SPORTBACK: 1RAH979**

Vinnumber:	<b>WAUZZZ8X2HB036790</b>	Versionname:	<b>1.4 TDI 66kW</b>
First Registrationdate:	<b>26/10/2016</b>	Fiscalpower:	
Expertise Mileage:	<b>31459</b>	Power Kw:	<b>66</b>
Bodytype:		Body color:	<b>Blue</b>
Gearbox:	<b>MAN 5 VIT</b>	Paint type:	<b>Metalic</b>
Transmission:	<b>Front</b>	Rims summer:	<b>Aluminium</b>
Fueltype:	<b>Diesel</b>	Oil level:	<b>OK</b>
Battery functioning:	<b>Yes</b>	Parking lot:	<b>4225</b>
Number of doors:	<b>5</b>		
Number of seats:	<b>5</b>		
Number head rests:	<b>5</b>		
Rims summer:	<b>Aluminium</b>		
Category:	<b>Passenger Car</b>		
Oil level:	<b>OK</b>		
Registration Certificate Car (BE):	<b>Yes</b>

**Limited Technical Inspection**

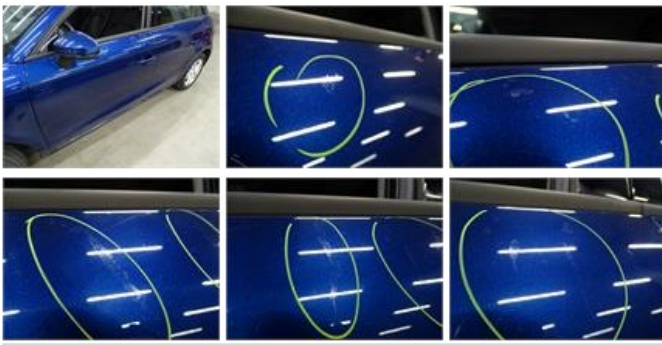
Total cost ex VAT	<b>370,24</b>
Door F L, Chemical polution, LI - Repair and paint (complete)	<b>254,68</b>
