LU Mercedes gla: GZ4693

Limited Technical Inspection

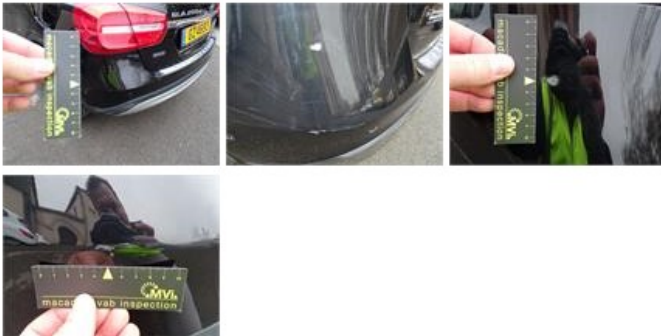
Bumper corner R L, Scratch(es), It - Spot repair 115,56
