LAND ROVER Evoque: 1FU1999

Limited Technical Inspection

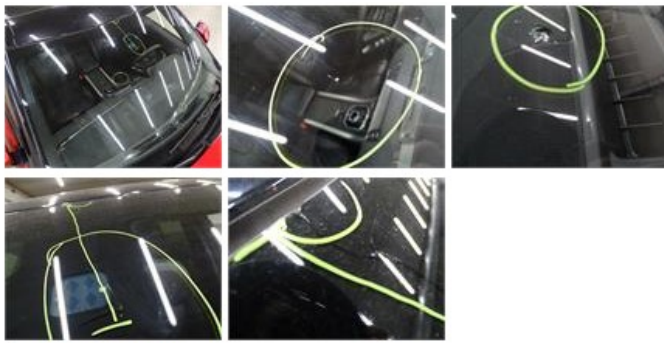
Windscreen, Tear, E - Replace	0,00
--------------------------------------	-------------

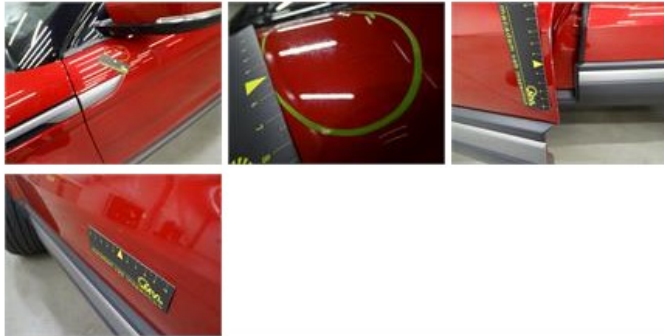
Door F L, Chemical polution, LI - Repair and paint (complete) 382,02

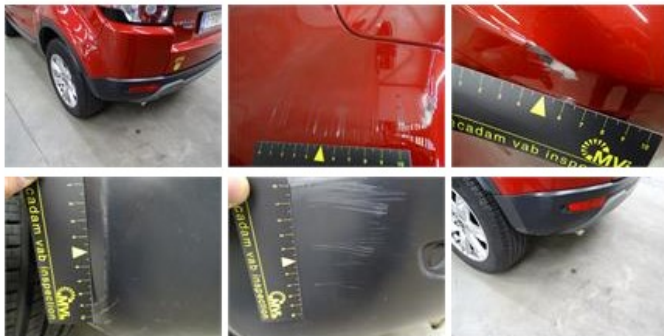
Bumper corner R L, Dent(s) and scratch(es), It - Spot repair 115,56

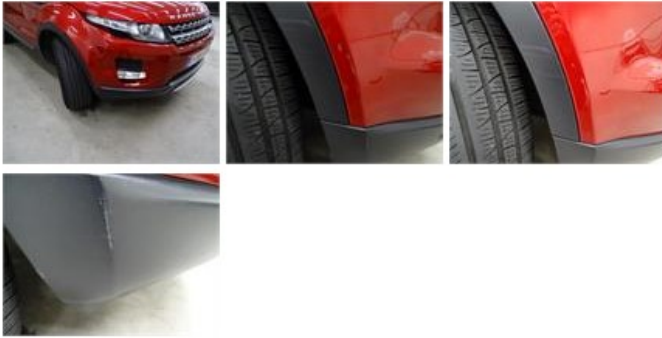
Bumper F R, Scratch(es), It - Spot repair 115,56

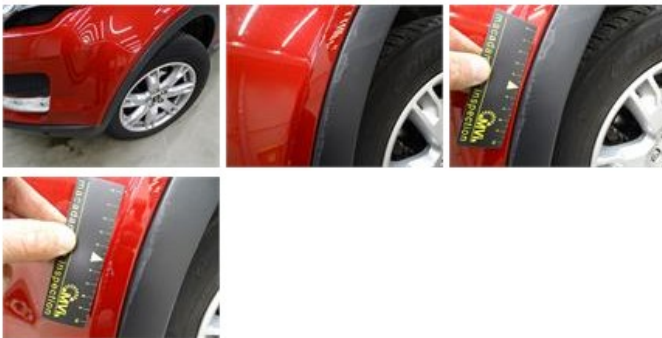
Bumper F L, Scratch(es), It - Spot repair 115,56
