**PEUGEOT 208: 1DQA545**

**Limited Technical Inspection**

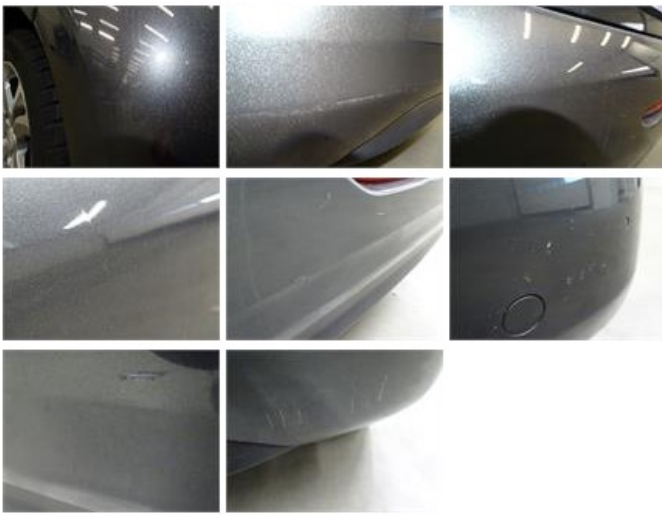
Bumper R, Scratch(es), LI - Repair and paint (complete) 169,44
