**VOLVO V40: 1GMF850**

**Limited Technical Inspection**

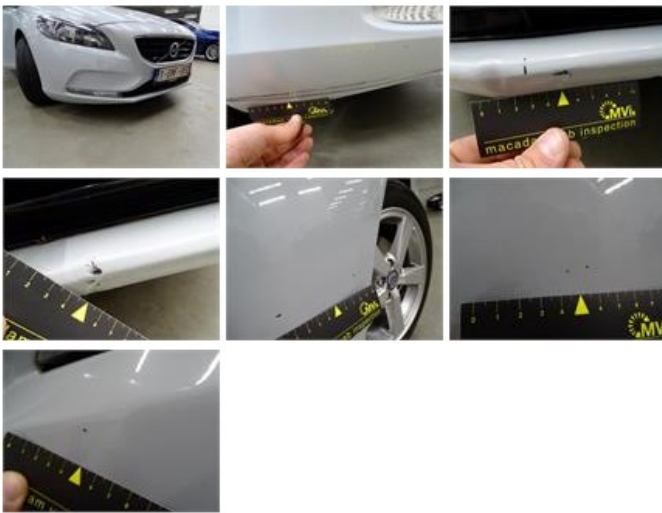
Total cost ex VAT	<b>1138,44</b>
Bumper F, Scratch(es), LI - Repair and paint (complete)	<b>211,80</b>

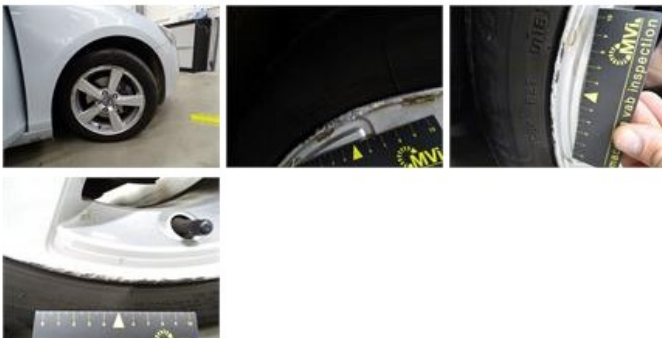
Alloy rim F R, Scratch(es), LI - Repair and paint (complete) 95,00

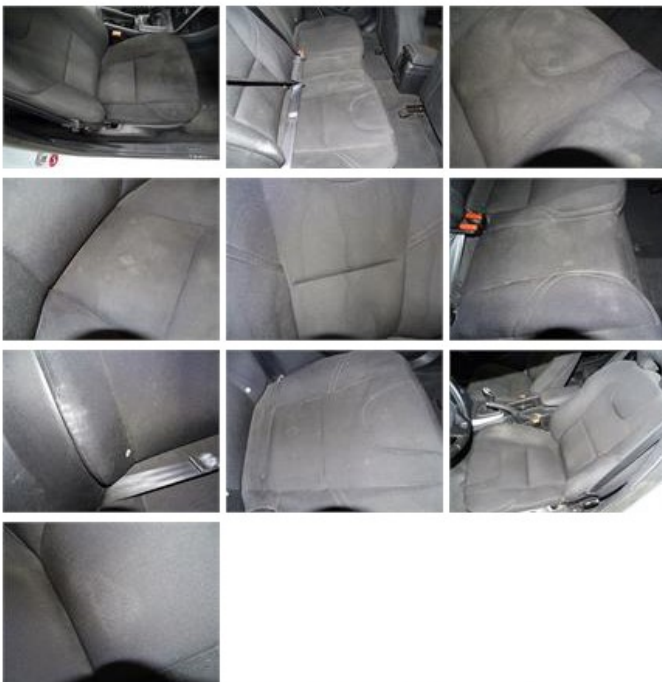
Interior, Dirty, Shampooing 100,00
