SKODA Superb: 1ESO443

Limited Technical Inspection

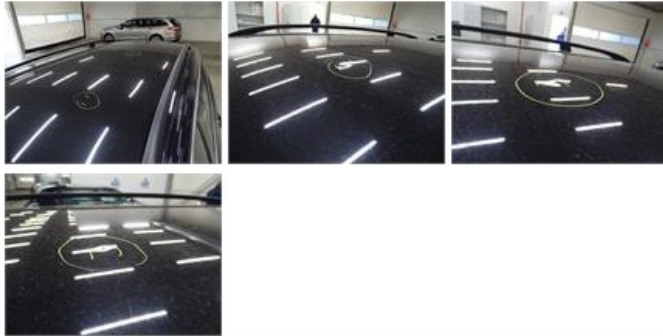
Roof, Dent(s), PDR - Paintless dent repair

102,60

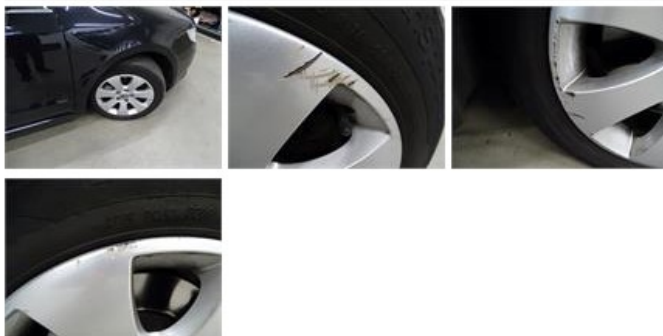
Alloy rim F R, Scratch(es), LI - Repair and paint (complete)

95,00
