RENAULT CAPTUR: 1NLR062

Limited Technical Inspection

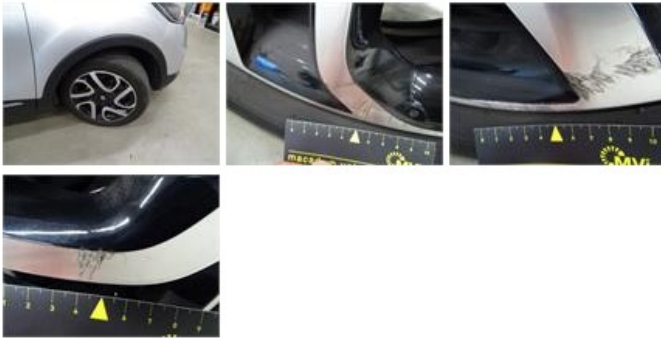
Alloy rim F R polished, Scratch(es), LI - Repair and paint (complete)	95,00
---	-------
