MERCEDES CLA: 1HVS894

Limited Technical Inspection

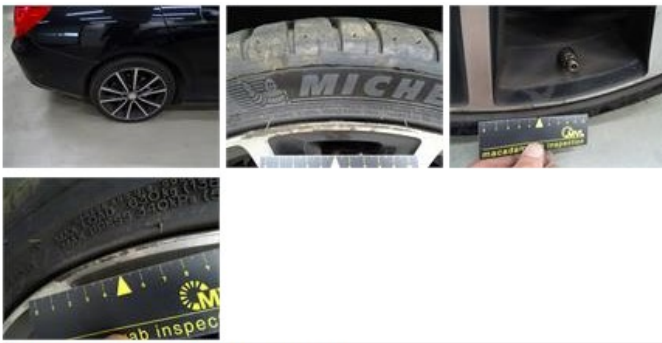
Alloy rim R R polished, Scratch(es), LI - Repair and paint (complete)	95,00
---	--------------

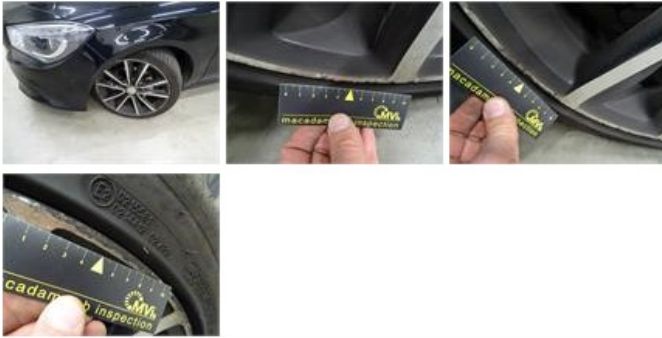
Alloy rim F L polished, Scratch(es), LI - Repair and paint (complete) 95,00

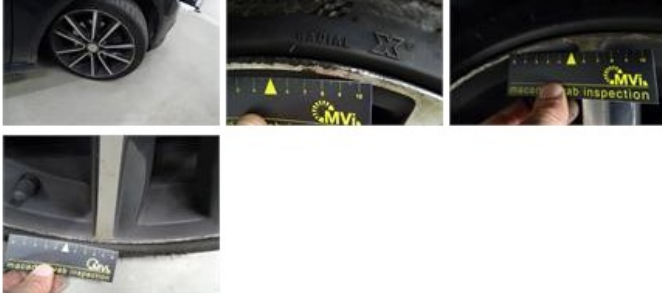
Alloy rim F R polished, Scratch(es), LI - Repair and paint (complete) 95,00
