**BMW 4 Gran Coupe: MA5382**

**Limited Technical Inspection**

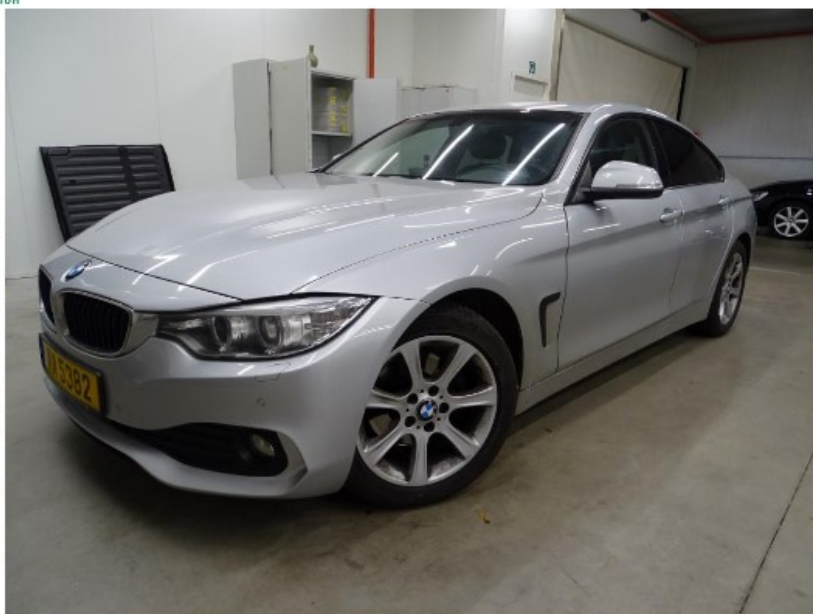
Repair kit	<b>Yes</b>	Compressor	<b>Yes</b>
Total cost ex VAT			<b>115,56</b>
Bumper F, Stone chip(s), Acceptable			<b>0,00</b>
<i>No pictures to display</i>			
Rearview mirror housing R, Scratch(es), LI - Repair and paint (complete)			<b>115,56</b>
