**BMW 2 Active Tourer: 1HYU610**

**Limited Technical Inspection**

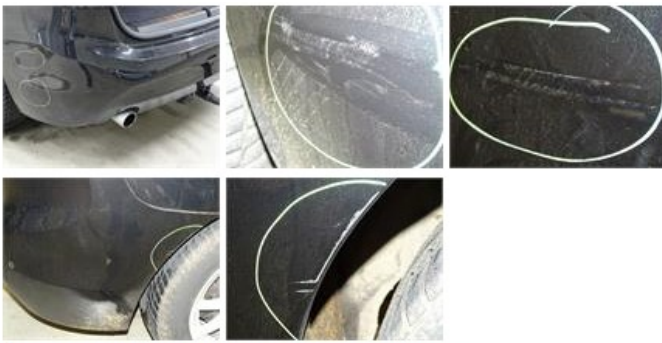
Bumper R, Dent(s) and scratch(es), LI - Repair and paint (complete)	<b>211,80</b>
---	---------------

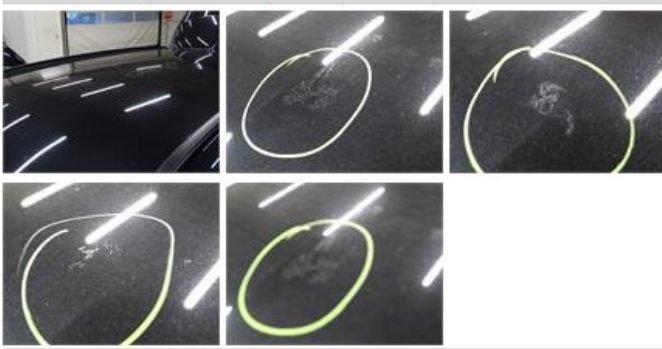
Roof, Chemical polution, LI - Repair and paint (complete) 481,50
