BMW 1: 1HTP579			
Vinnumber:	WBA1X510X0J781869	Versionname:	1 SPORTSHATCH 118dX 143PK
First Registrationdate:	30/09/2014	Fiscalpower:	
Expertise Mileage:	88310	Power Kw:	105
Bodytype:	Hatchback	Body color:	Black
Gearbox:	MAN 6 VIT	Paint type:	Metallic
Transmission:	Back	Rims summer:	Aluminium
Fueltype:	Diesel	Oil level:	OK
Battery functioning:	Yes	Parking lot:	1105
Number of doors:	3		
Number of seats:	5		
Number head rests:	5		
Rims summer:	Aluminium		
Category:	Passenger Car		
Oil level:	OK		
Registration Certificate Car (BE):	Yes

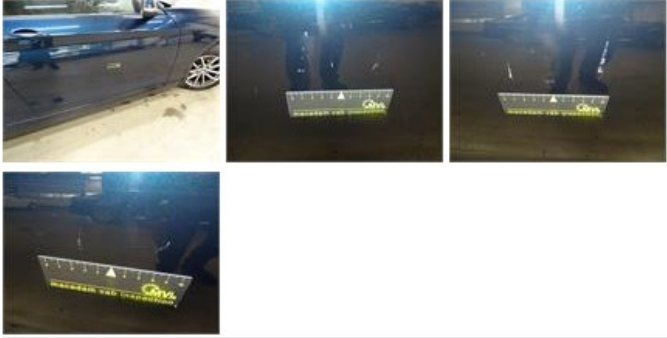
Door F R, Scratch(es), LI - Repair and paint (complete) 0,00

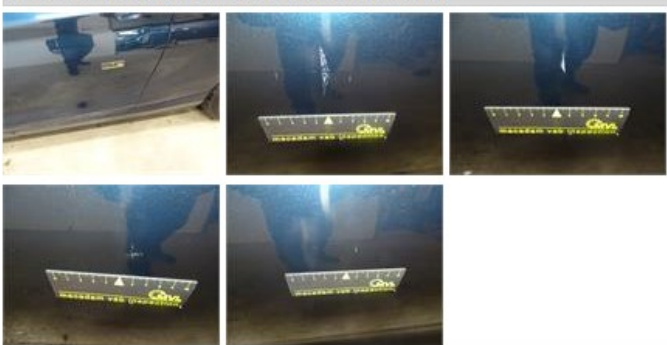
Door F L, Scratch(es), LI - Repair and paint (complete) 0,00

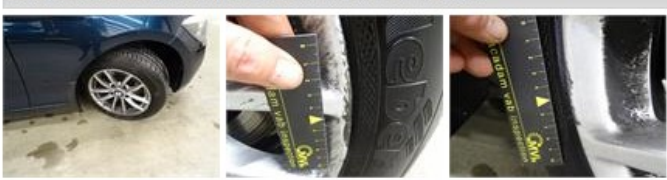
Alloy rim F R, Scratch(es), LI - Repair and paint (complete) 95,00

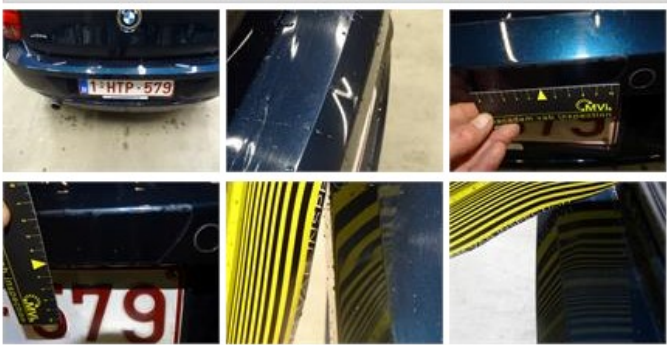
Bumper R, Dent(s) and scratch(es), LI - Repair and paint (complete) 211,80
