BMW 5: NA4045

Limited Technical Inspection

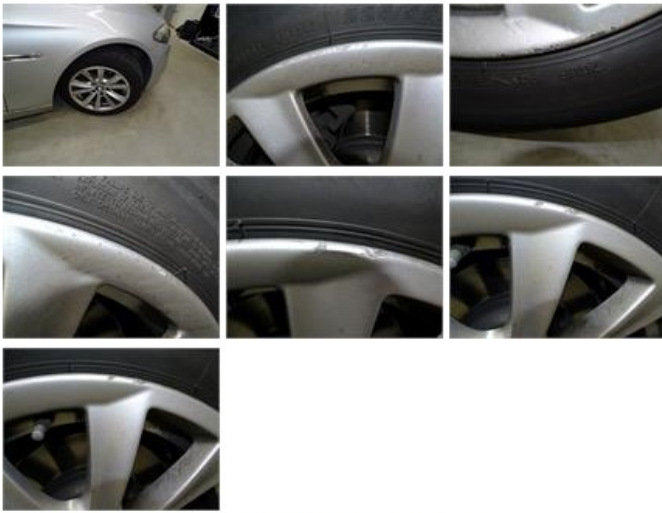
Alloy rim F R, Scratch(es), LI - Repair and paint (complete)	95,00
--	--------------

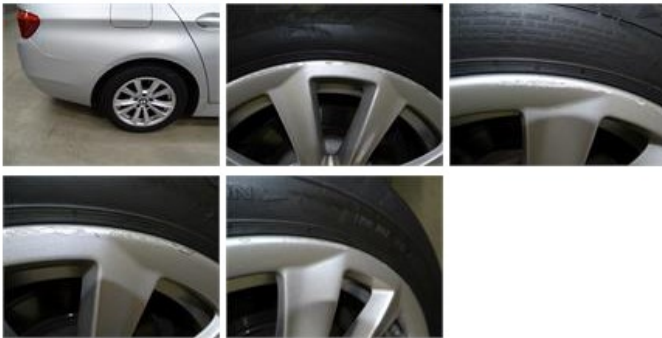
Alloy rim R R, Scratch(es), LI - Repair and paint (complete)	95,00
--	-------

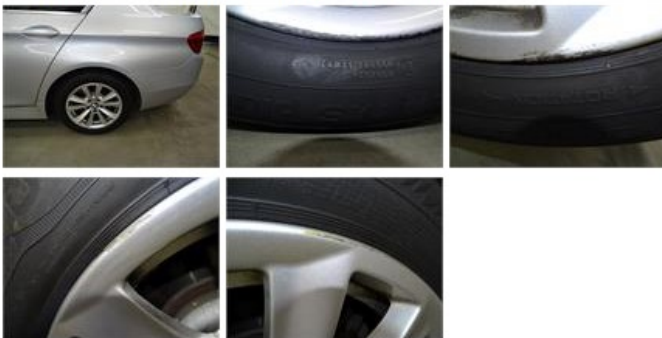
Alloy rim R L, Scratch(es), LI - Repair and paint (complete)	95,00
--	-------
