<b>AUDI A3: 1JAB251</b>			
Vinnumber:	<b>WAUZZZ8V9FA078553</b>	Versionname:	<b>A3 SB Ambiente 110PK</b>
First Registrationdate:	<b>13/11/2014</b>	Fiscalpower:	
Expertise Mileage:	<b>132322</b>	Power Kw:	<b>81</b>
Bodytype:		Body color:	<b>Black</b>
Gearbox:	<b>MAN 6 VIT</b>	Paint type:	<b>Metalic</b>
Transmission:	<b>Front</b>	Rims summer:	<b>Aluminium</b>
Fueltype:	<b>Diesel</b>	Oil level:	<b>OK</b>
Battery functioning:	<b>Yes</b>	Parking lot:	<b>3402</b>
Number of doors:	<b>5</b>		
Number of seats:	<b>5</b>		
Number head rests:	<b>5</b>		
Rims summer:	<b>Aluminium</b>		
Category:	<b>Passenger Car</b>		
Oil level:	<b>OK</b>		
Registration Certificate Car (BE):	<b>Yes</b>

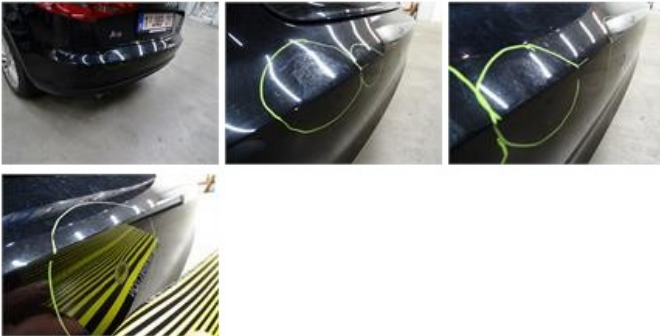
Bumper R, Chemical polution, LI - Repair and paint (complete) 211,80

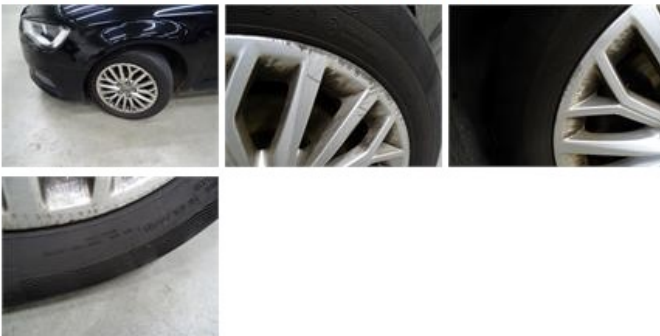
Alloy rim F L, Scratch(es), LI - Repair and paint (complete) 95,00

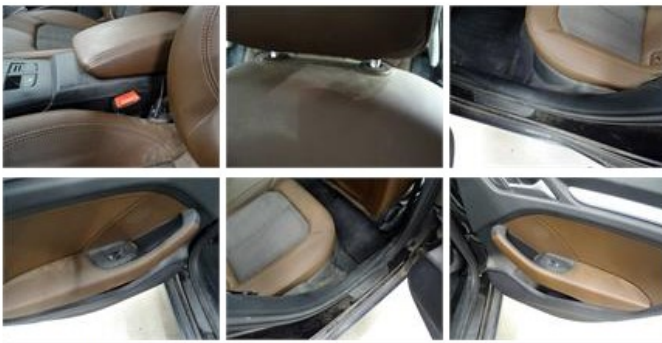
Interior, Dirty, Cleaning 0,00

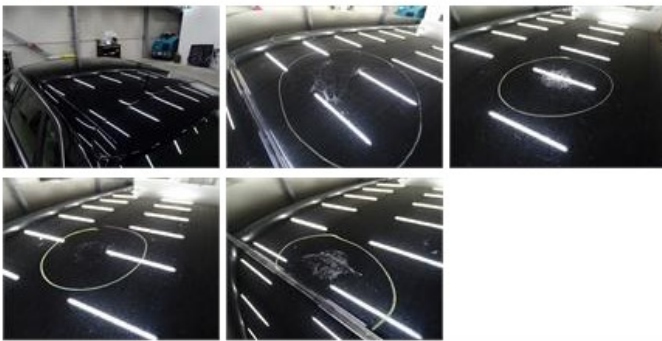
Roof, Chemical polution, LI - Repair and paint (complete) 481,50
