MERCEDES CLA: 1FWF213

Limited Technical Inspection

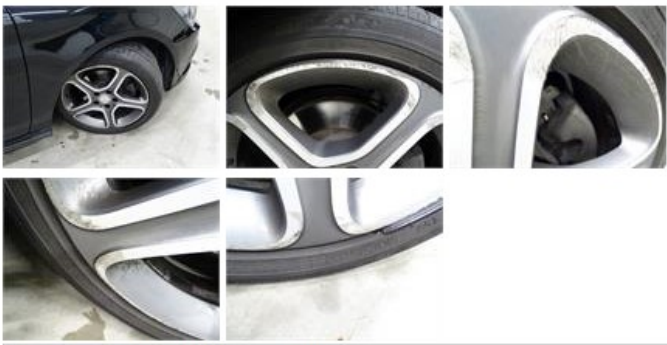
Door F L, Scratch(es), Acceptable	0,00
<i>No pictures to display</i>	
Alloy rim F R polished, Scratch(es), LI - Repair and paint (complete)	95,00
