**SKODA Octavia: 1FXK505**

**Limited Technical Inspection**

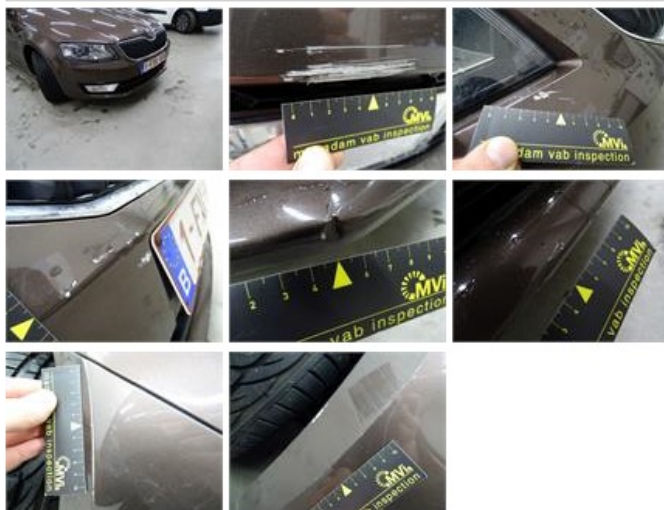
Bumper F R, Scratch(es), It - Spot repair

115,56

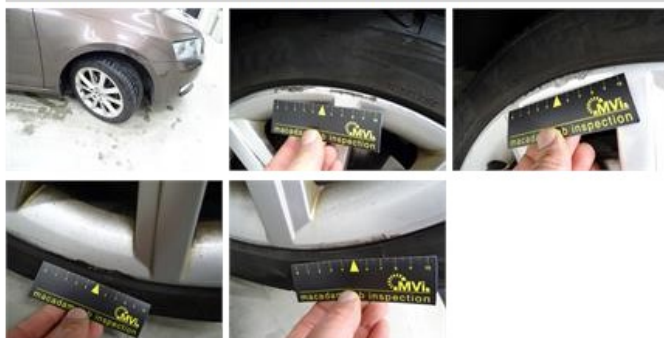
Alloy rim F R, Scratch(es), LI - Repair and paint (complete)

95,00

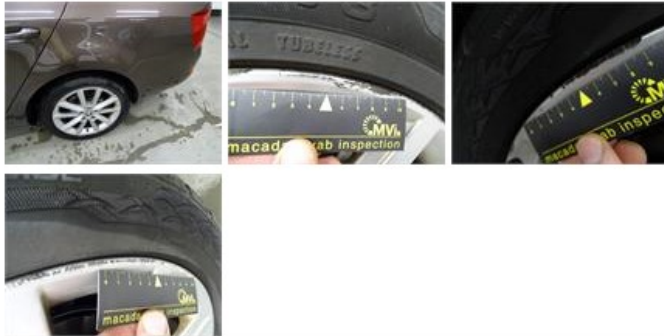
Alloy rim R L, Scratch(es), LI - Repair and paint (complete)

95,00
