**VOLVO V60: 1KDS132**

**Limited Technical Inspection**

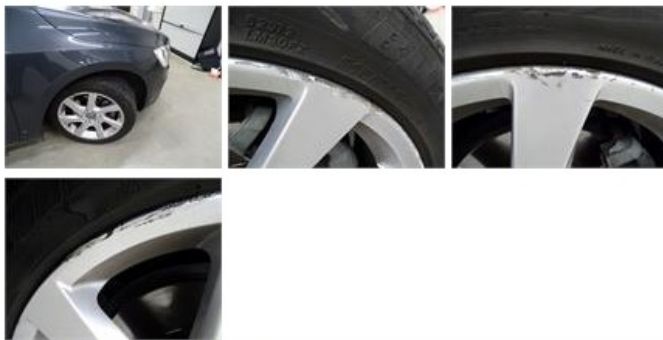
Alloy rim F R, Scratch(es), LI - Repair and paint (complete)

95,00

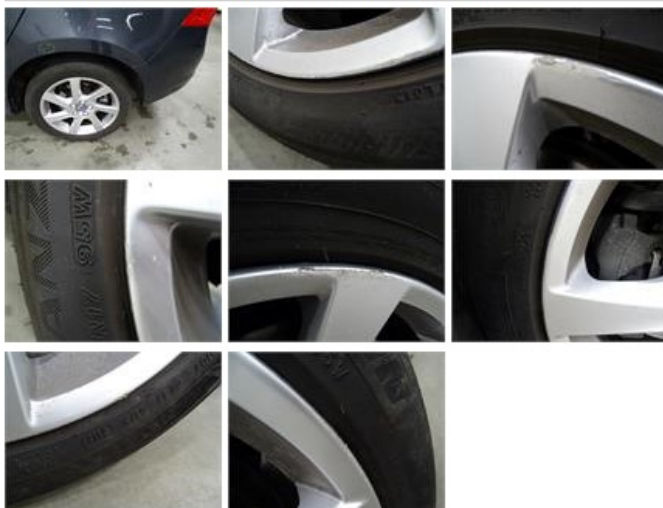
Alloy rim R L, Scratch(es), LI - Repair and paint (complete)

95,00

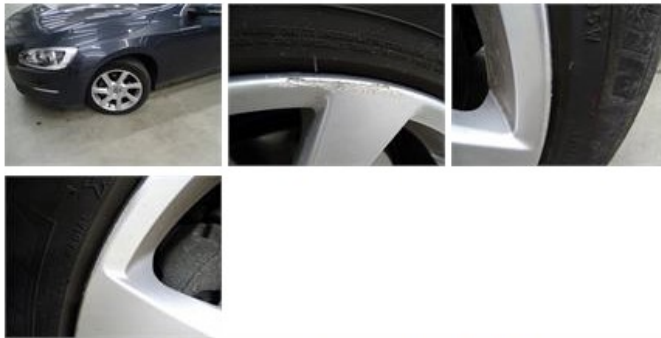
Alloy rim F L, Scratch(es), LI - Repair and paint (complete)

95,00

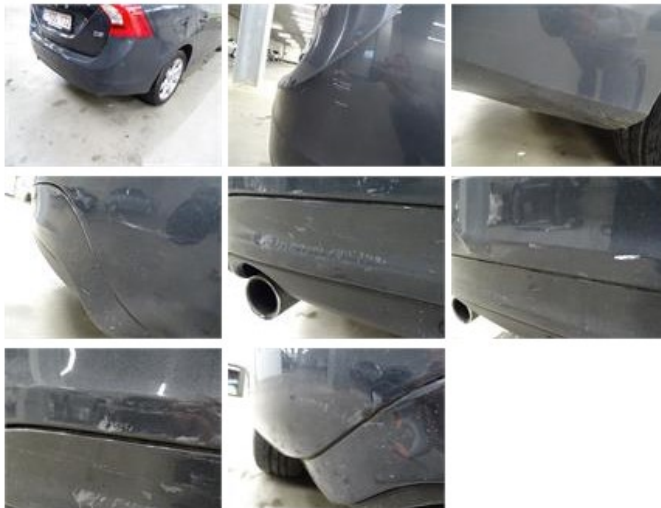
Bumper R, Dent(s) and scratch(es), LI - Repair and paint (complete)

211,80
