NISSAN Qashqai: 1GTQ183

Limited Technical Inspection

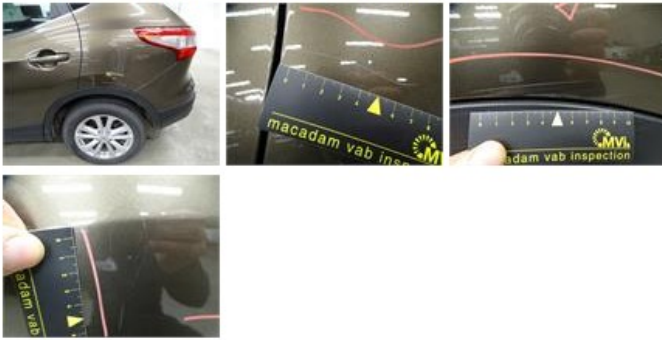
Wing R L, Scratch(es), LI - Repair and paint (complete) 308,20

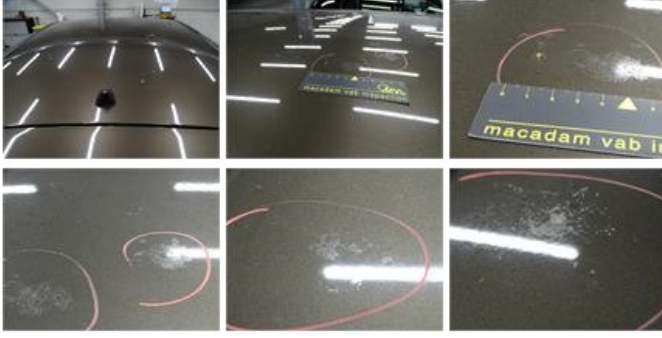
Roof, Chemical polution, LI - Repair and paint (complete) 481,50
