VOLVO XC60: 1JLT475

Limited Technical Inspection

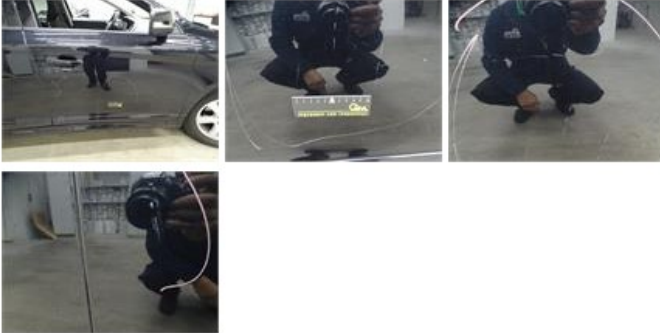
Door F R, Scratch(es), LI - Repair and paint (complete) 382,02
