| BMW 3: XC8691 | | | |
| Vinnumber: | WBA3Y31030D772469 | Versionname: | 3 GRAN TURISMO 320da 184PK Aut. |

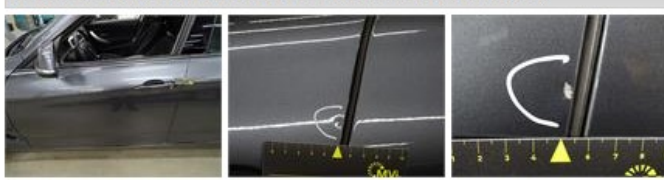
| Door F L, Dent(s) and scratch(es), LI - Repair and paint (complete) | | | 318,35 |

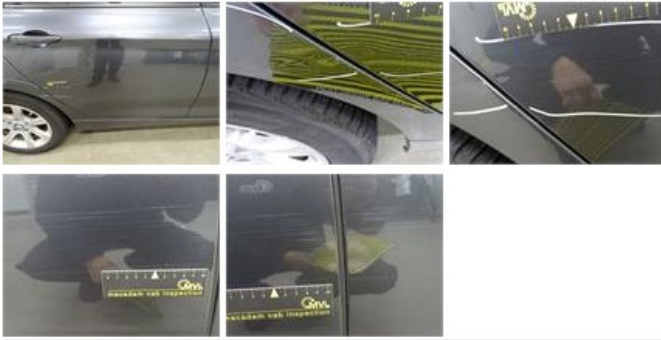
Door R R, Dent(s) and scratch(es), LI - Repair and paint (complete)

318,35

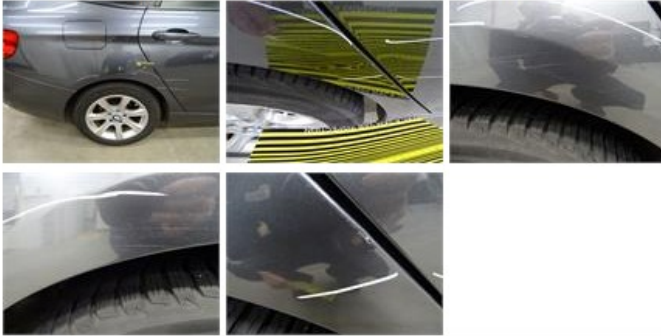
Wing R R, Dent(s) and scratch(es), LI - Repair and paint (complete)

308,20

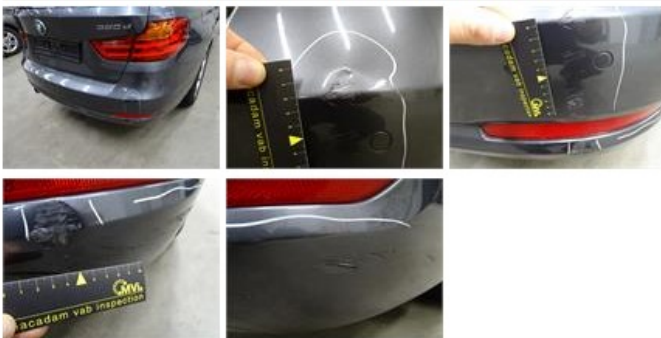
Bumper R, Dent(s) and scratch(es), LI - Repair and paint (complete)

211,80
