BMW X5: XC8677

Limited Technical Inspection

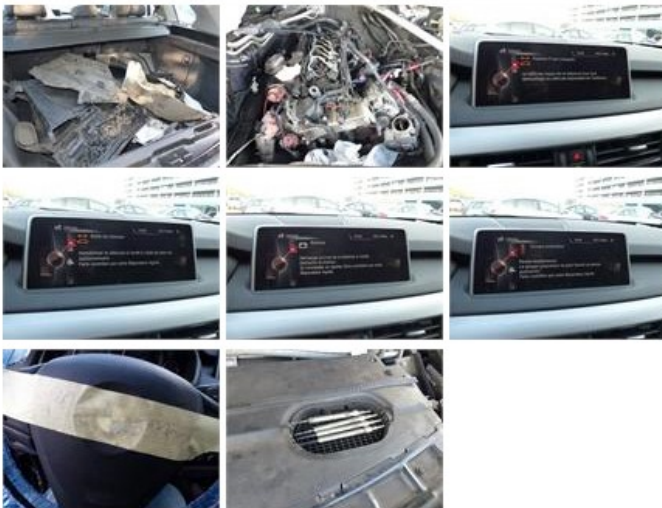
Engine, Not functioning (well), Diagnosis 0,00
