<b>BMW 3: 1FIQ648</b>			
Vinnumber:	<b>WBA3K11020F825754</b>	Versionname:	<b>3 TOURING 318d 136PK</b>
First Registrationdate:	<b>9/07/2013</b>	Fiscalpower:	
Expertise Mileage:	<b>109643</b>	Power Kw:	<b>100</b>
Bodytype:	<b>Break</b>	Body color:	<b>Dark Grey</b>
Gearbox:	<b>MAN 6 VIT</b>	Paint type:	<b>Metalic</b>
Transmission:	<b>Back</b>	Rims summer:	<b>Aluminium</b>
Fueltype:	<b>Diesel</b>	Oil level:	<b>OK</b>
Battery functioning:	<b>Yes</b>	Parking lot:	<b>3202</b>
Number of doors:	<b>5</b>		
Number of seats:	<b>5</b>		
Number head rests:	<b>5</b>		
Rims summer:	<b>Aluminium</b>		
Category:	<b>Passenger Car</b>		
Oil level:	<b>OK</b>

<b>Limited Technical Inspection</b>			
Airco functioning	<b>OK</b>	Battery functioning	<b>Yes</b>
Tires wear profile	<b>OK</b>	Power steering	<b>Yes</b>
Idle position	<b>OK</b>	Sound engine	<b>OK</b>
Engine startingtime	<b>OK</b>	Clutch test	<b>OK</b>
Exhaust gass	<b>OK</b>	Wiper fluid level	<b>OK</b>
Handbrake	<b>OK</b>	Transmission	<b>OK</b>
		Lighting	<b>OK</b>
		Wiperblades	<b>OK</b>

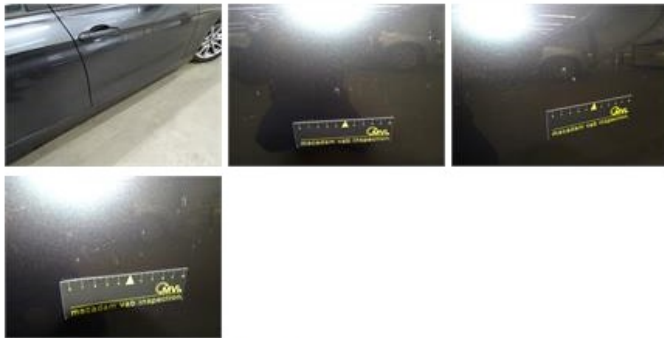
Door F R, Scratch(es), LI - Repair and paint (complete)

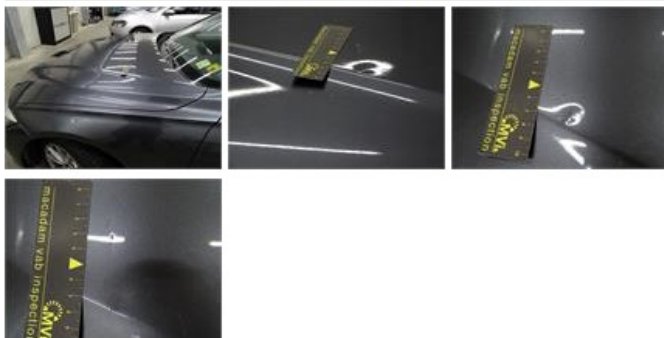
Bonnet, Dent(s) and scratch(es), LI - Repair and paint (complete)

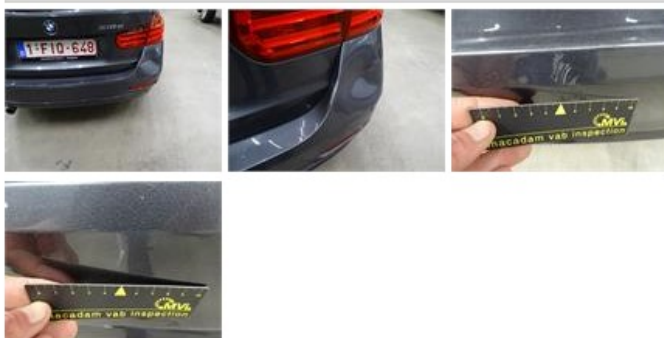
Bumper R, Dent(s) and scratch(es), Le - Replace and paint
