**BMW 3 TOURING: 1JFV985**

**Limited Technical Inspection**

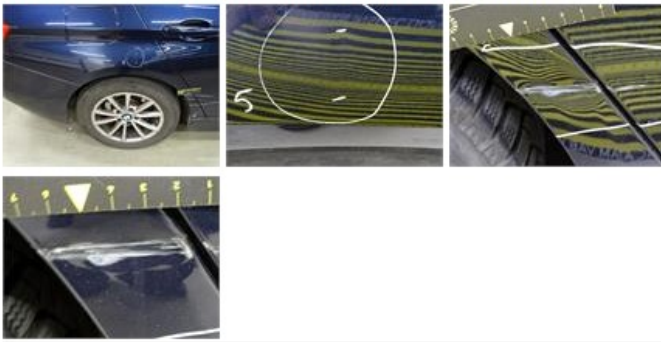
Wing R R, Dent(s) and scratch(es), LI - Repair and paint (complete)

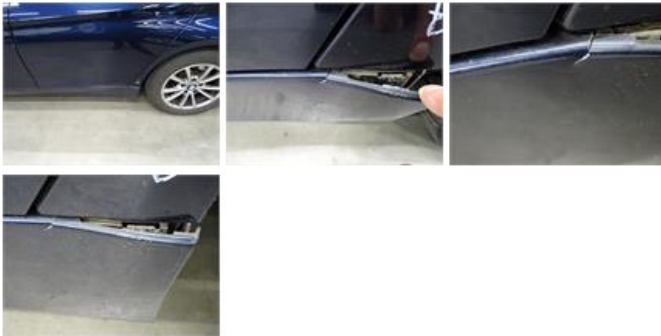
Sill outer L, Deformed / Strained, LI - Repair and paint (complete)

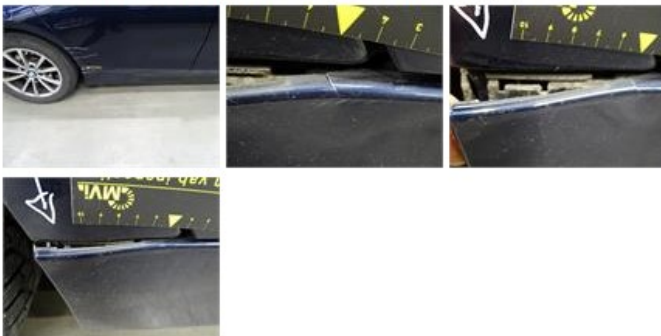
Sill outer R, Deformed / Strained, LI - Repair and paint (complete)

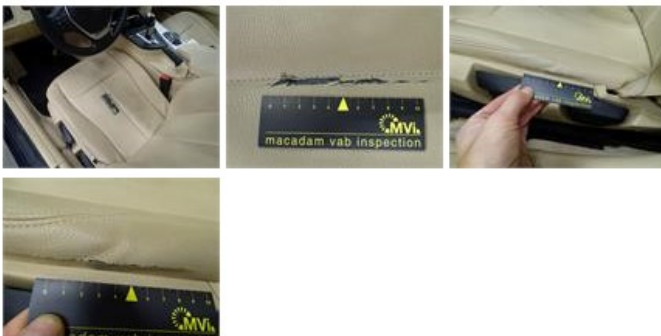
Seat cover F L, Worn, Acceptable

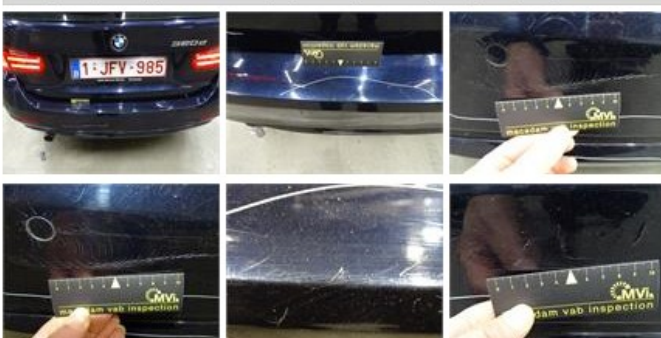
Bumper R, Dent(s) and scratch(es), LI - Repair and paint (complete)
